KISH P & I LOSS PREVENTION CIRCULAR KPI-LP-102-2013
(Improperly moored bunker vessels & Lessons to be Learnt)

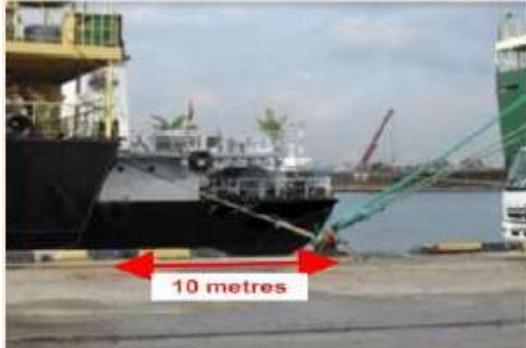
In some ports and terminals, bunker supply barges tend to moor on the sea side of ships with a considerable length of their hull overhanging the stern of receiving vessels. Such a practice shows poor seamanship and is hazardous for both the barge and the vessel moored at or manoeuvring off the next berth.

Unsafe overhang severely restricts manoeuvring room for the vessel berthed astern and increases risk of contact during mooring/unmooring

'Inconvenient' locations of the manifolds on the supplying or receiving vessels should be remedied by joining additional hose lengths instead of inconsiderate positioning of the barge.

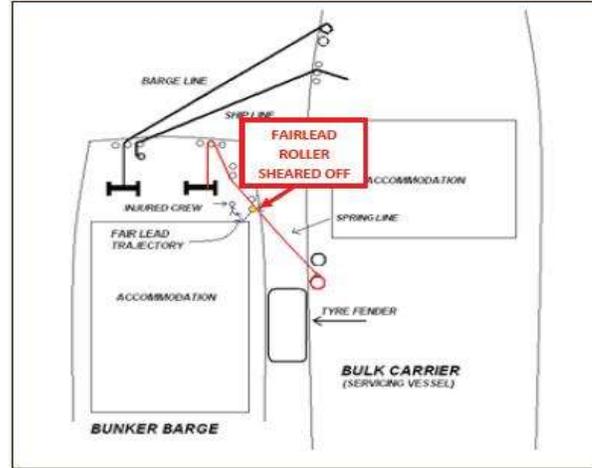
Mooring arrangement at the time of accident

Due to the large difference in freeboard between the two vessels, the mooring lines from the barge's deck were all leading upwards subjecting the roller to a combination of large cyclical sideways thrust and lifting force. Ultimately, material weakness and fatigue caused by corrosion and wastage within the roller's body caused it to shear off from the base.

1. A proper risk assessment must be conducted before commencing mooring operations, taking into account the effects of sea state, difference in freeboard, lead angles of lines and prevailing circumstances and conditions;
2. Mooring plan must be jointly discussed and approved by both supplying and receiving vessels; If additional safety measures are not considered to mitigate risks to an acceptable level, the bunker transfer must be cancelled / postponed;
3. Mooring equipment must be properly inspected and maintained as per a documented planned maintenance system (PMS).
