KISH P & I LOSS PREVENTION CIRCULAR KPI-LP-125-2013 **(Air Reservoir Drainage Operation Causing Fatality)**

The purpose of this Marine Notice is to draw industry attention to a fatality on board a foreign flagged vessel in Australian waters.

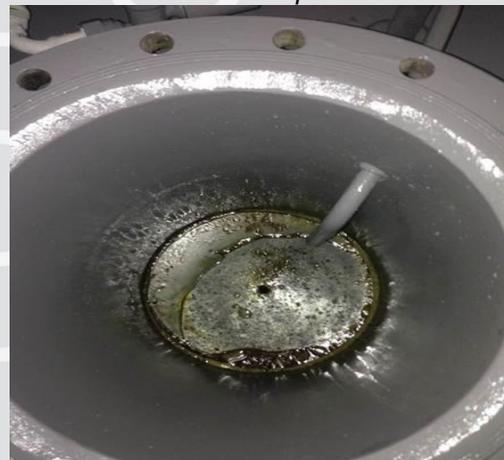
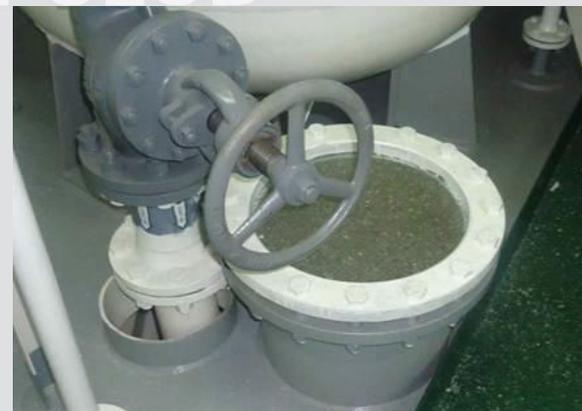
On this vessel the blow down pipe from the reservoir after the drain valve is led to a small cylindrical observation pot, the top of which is covered by an observation glass attached in place by bolts and a flat steel retaining ring. At the bottom of the pot a small hole of approximately 10-12 mm is drilled which allows the emulsion to be drained and led away for disposal.

Although, it is not clear as to the actual sequence of events, it is understood that the fourth engineer was fatally injured when the glass on the observation pot of a main air reservoir exploded and the flying debris struck his face.

Observation pot drain
Glass covered observation pot

All ship owner/managers, seafarers, classification society and independent surveyors, and all other stakeholders who come across a vessel with similar drainage arrangements are requested to take notice of this tragic incident and take appropriate actions.
