KISH P & I LOSS PREVENTION CIRCULAR KPI-LP-168-2014
(Not Wearing Lifejacket nor A Lifeline; Ending Up Dead)

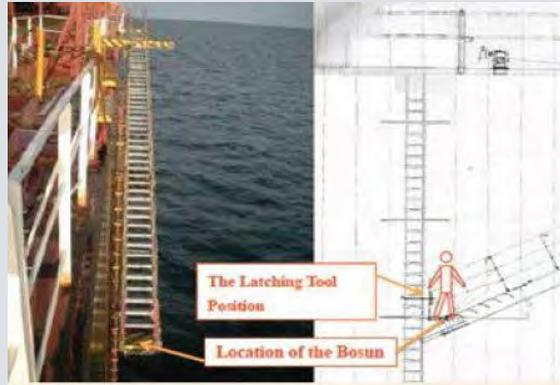
accommodation ladder. Each time the crew tried to hoist the ladder; it descended rather than moving up. After a few attempts, the crewman stopped the operation, but at this time a noise was heard and the crew realized the accommodation ladder was now hanging vertically down. The bosun could not be seen; he had not been wearing a lifejacket nor a lifeline.

1- The investigation found it probable that when the ladder was mistakenly lowered (instead of being raised), the weight of the ladder transferred from the hoisting wire to the latching mechanism. The mechanism failed under a load that it was not designed to hold, and the resulting shock load on the wire caused failure and free fall of the lower end of the accommodation ladder, leaving it in the vertical position.

2- The investigation also found it probable that the non-permanent air hose connections for powering the hoist/lower function of the accommodation ladder, which were unmarked, were mistakenly inversed when connected initially, hence the lowering action achieved when the crew wanted to hoist.

3- Additionally, it was found that the wire on the failed accommodation ladder was in fact

only 55 metres long instead of the manufacturer's recommended 67 metres. This probably caused undue stress and further undermined the wire's integrity, especially considering that at least two wraps were needed on the drum at maximum payout.
