KISH P & I LOSS PREVENTION CIRCULAR KPI-LP-23-2012
(Oil Cargo Spill & Lessons to be Learnt)

Accident description: Oil cargo spill from tank washing line drain cock

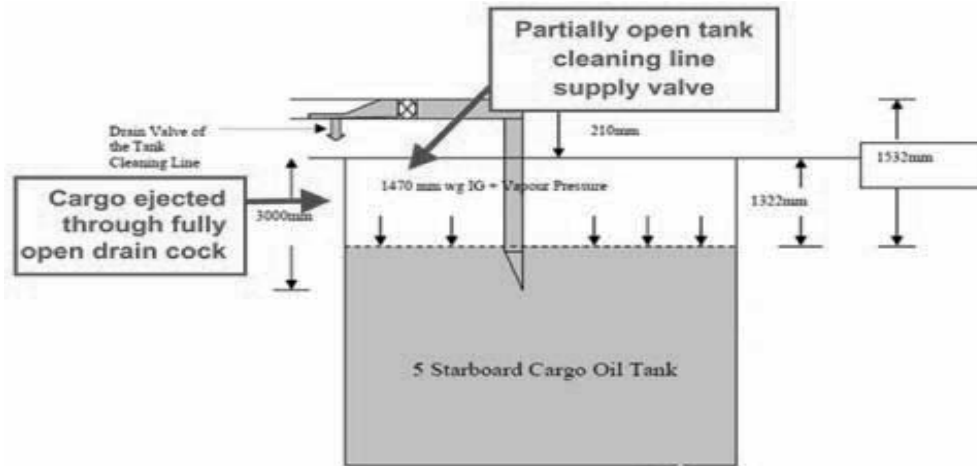
The crew found that cargo was coming out through the open drain cock on the tank cleaning line branch to 5 Starboard Cargo Oil Tank (COT). This valve was immediately shut, and the deck team then discovered that the supply valve for 5S. Tank Cleaning machine was also partially open. The supply valve was then also closed tight. Although no oil or sheen was visible in the ship's wake, it is possible that some oil could have escaped to the sea during the hours of darkness.

1. Faulty design: The supply valve for 5S tank cleaning machine was found partially open despite the order for all valves to be closed. All these valves were fitted with long operating handles very near deck level which could easily get in the way of a person walking past. During the final stages of loading, many ship and shore personnel were on deck in the vicinity of this valve handle as the tank was gauged and sampled. It is possible that anyone, particularly a shore person, could have accidentally kicked the valve handle and opened it without knowing the consequences;

2. Crew negligence & complacency: All tank cleaning line valves in this vessel are designed to accommodate a locking arrangement but many locking pins were missing and therefore the valves could not be positively secured in closed position;

3. The drain cock of the tank cleaning line was kept open as a precaution against freezing. This resulted in only a single valve barrier between cargo tank and the environment, which presented an unacceptable pollution risk;

4. With the near-full loaded condition, the tank cleaning machines were submerged in the cargo. The increase in vapour pressure inside the tank due to cargo sloshing resulted in the cargo being pushed up into the tank cleaning line. The cargo then passed through the partially opened tank cleaning valve and fully opened drain valve on to the deck, resulting in the oil cargo spilling on deck;

1. A safety meeting was conducted by the marine superintendent at the next port and the incident was discussed in detail;
2. Crew re-trained on proper post tank-cleaning/pre-loading procedures;
3. Pre-loading check list has been amended to include the closing of all tank cleaning line valves, drain cocks/caps;
4. Missing locking pins on all valve handles have been renewed;

5. Placards have been posted near all tank cleaning and line drain valves to ensure they are closed prior to any cargo operation;
6. Chief Officer's standing instructions have been amended to ensure that all drain valves are positively shut after tank cleaning operations;
7. Incident made part of pre-boarding briefing for all officers.
