KISH P & I LOSS PREVENTION CIRCULAR KPI-LP-47-2012

(A Collision South of Dungeness & Lessons to be Learnt)

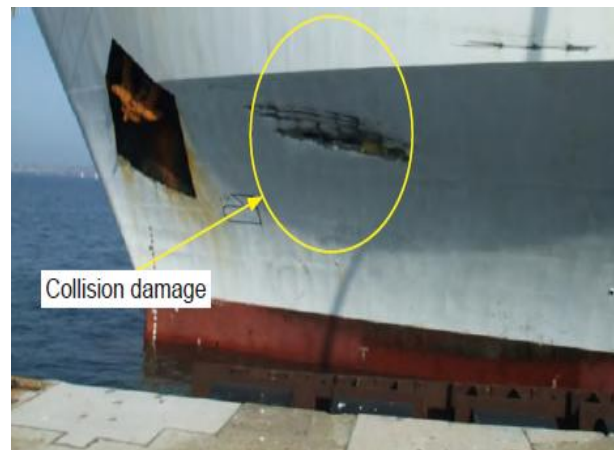
GA suffered a breach of her hull, shell indentation and damage to fairleads and railings on her starboard quarter. SB was holed on the port bow and her collision bulkhead was penetrated.
