Collision during STS berthing operation

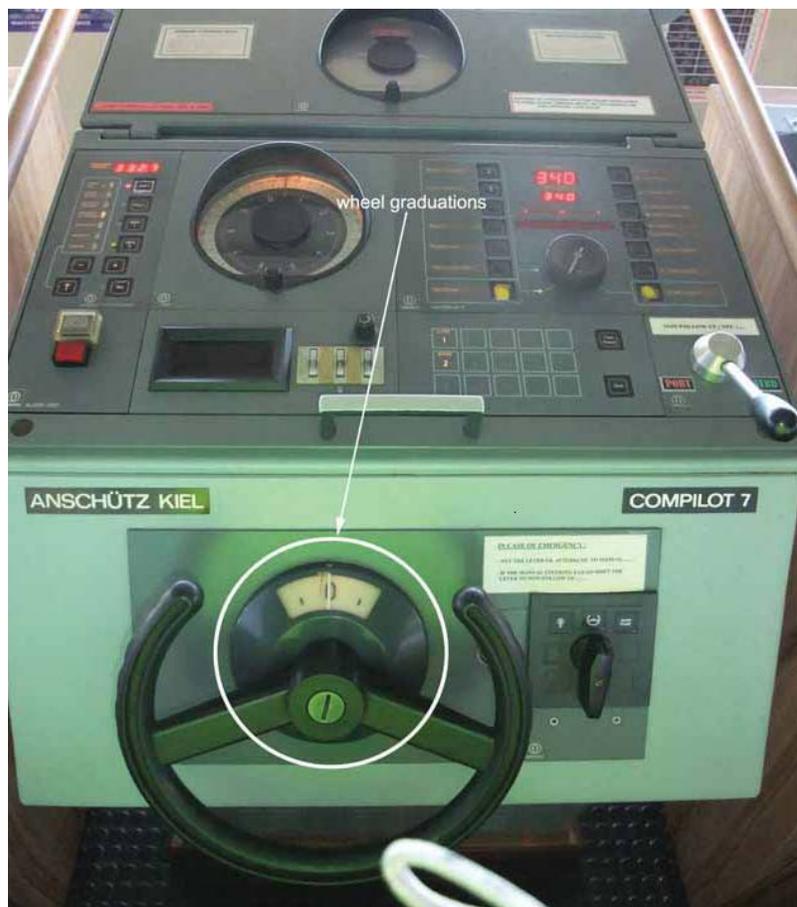
Figure 1: Bridge steering console

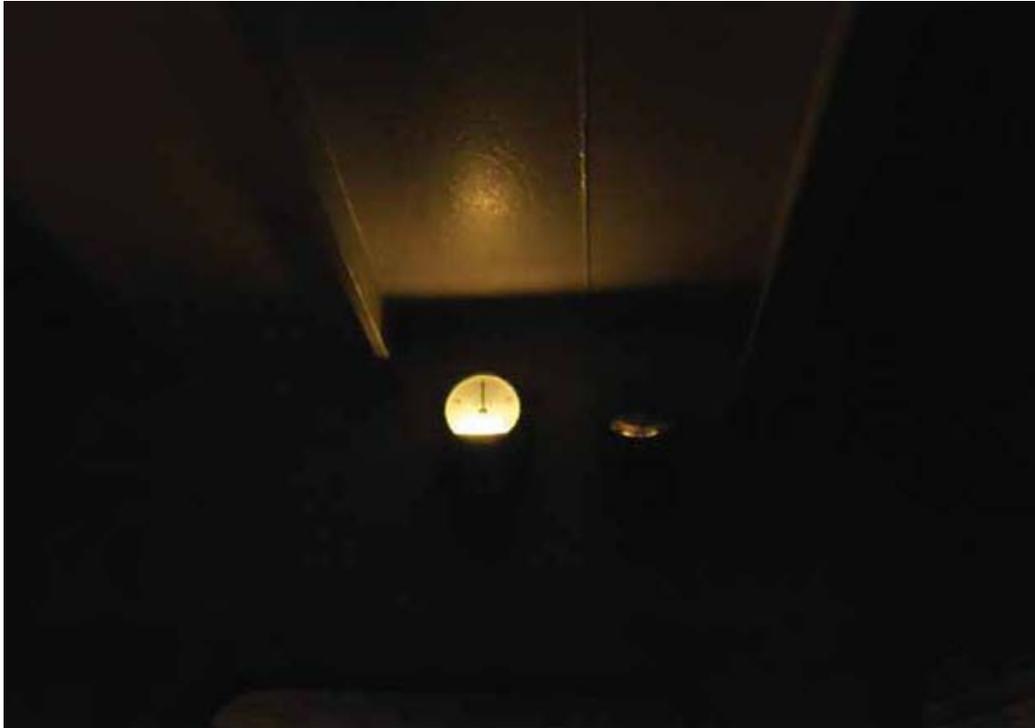
Due to a delay caused by re-rigging the fenders earlier that afternoon, the run-in was now to occur in darkness, as agreed by the masters of both tankers. The sea state was slight, with a light wind on the starboard bow, and it was a moonlit night. The exterior bridge wing helm indicator illumination was very poor and could not be seen from the superintendent’s position.

Figure 2: Poor illumination of bridge wing instrumentation

A poorly illuminated indicator is of little value at night (see photograph).

The instrumentation needs to be regularly maintained and checked to ensure its functionality, particularly before critical operations such as those described above.
