Real Life Accident: Rescue Boat Falls In Water During Drill With Crew Members Inside, One Dies

FEBRUARY 21, 2014 BY MARS
REPORTS

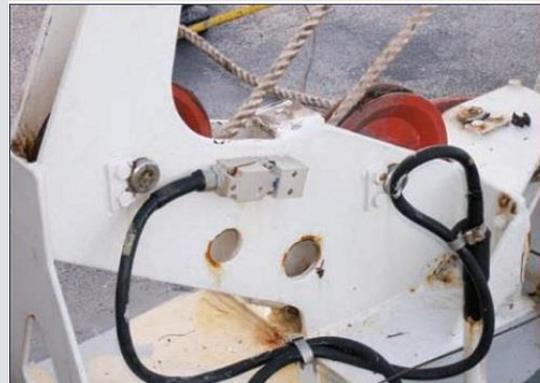
The proximity sensor/limit switch was tested in situ and was found to be defective. It had been installed in 2006, and during the ill-fated drill, was not tested before hoisting was commenced.

▲ Figure 1: View of proximity sensor/limit switch arrangement on davit (Note cable entry gland position raised above horizontal, potentially permitting ingress of water)

- The proximity switch was incorrectly fitted with its cable entry gland higher than the switch body thereby increasing the possibility of water ingress.

- Test all proximity switches on each occasion before hoisting operations commence;

- Replace all proximity switches every two years;
- Exercise caution when using pressure washers in the vicinity of these sensors/switches.

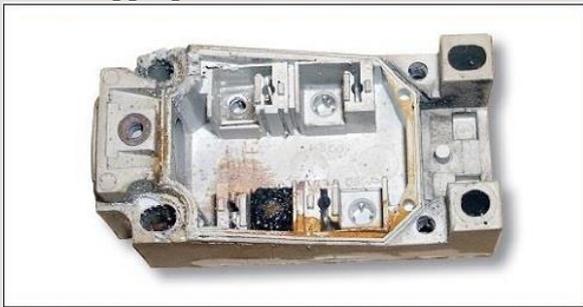
Inspection revealed evidence of water ingress (Figure 2), although subsequent tests showed that the switch malfunctioned due to an unrelated electronic fault.

▲ Figure 2: Evidence of water ingress within proximity sensor/switch body

- Follow manufacturers’ recommendations regarding the maintenance and periodic testing, examination and replacement of safety devices, seeking clarification from manufacturers where ambiguity exists;
- Verify the effectiveness of watertight seals on electrical equipment fitted to boat davit systems on weather decks.

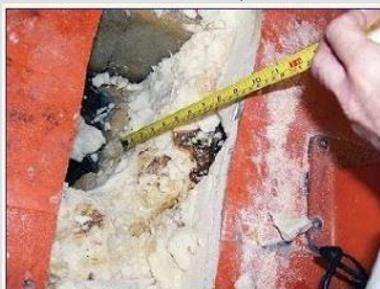
During the investigations, it was also unexpectedly discovered that water had entered the foam-filled buoyancy spaces between the inner and outer fibreglass skins of the rescue boat's hull (Figures 3 & 4). The craft was found to be approximately 450 kg overweight. Although the additional weight of water caused the davit's SWL to be exceeded, it was established that this would not have caused the wire to fail.

◀ Figure 3: Water seen in buoyancy space between inner and outer fiberglass skins of rescue boat

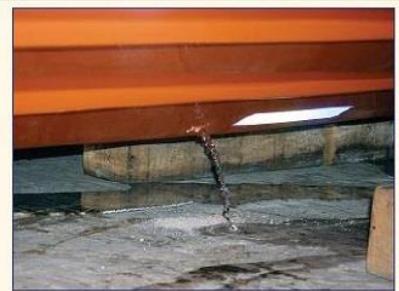
Figure 4: Accumulated water being drained through hole made in outer hull of rescue boat
