KISH P & I LOSS PREVENTION CIRCULAR KPI-LP-02-2012

Case: Grounding and subsequent loss of a container vessel

Location: Astrolabe Reef, Bay of Plenty, New Zealand, 37° 32.4'S 176° 25.7'E

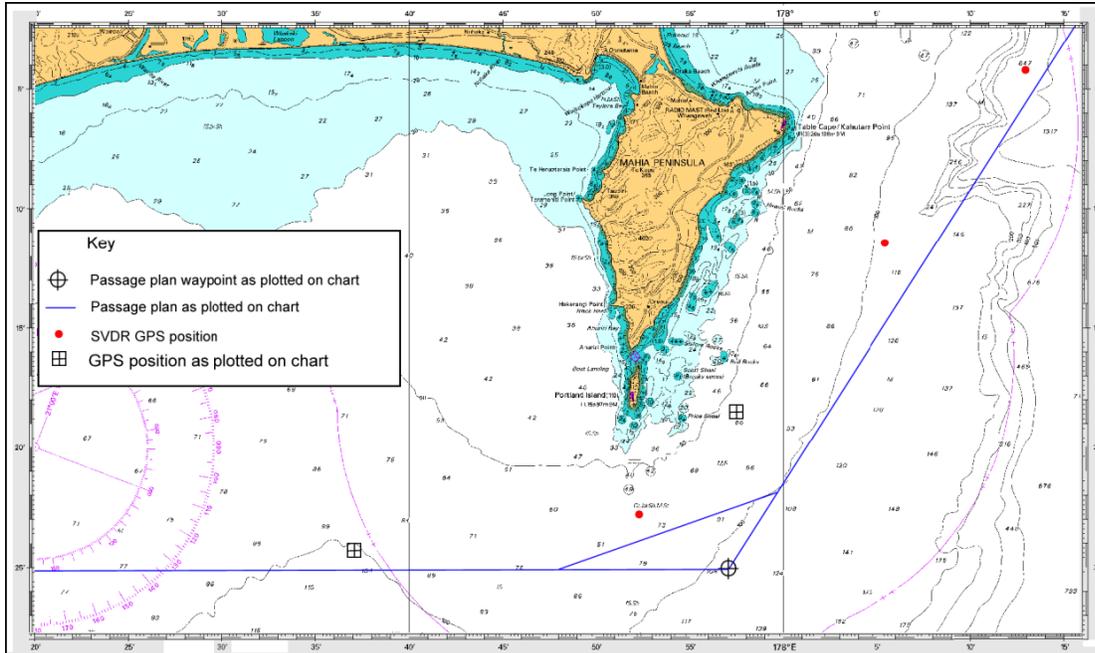
B) The passage plan had been prepared but later altered/amended by the master so as to shorten the distance. *Commercial obligations-Compromising safety*

- 6- Making short cuts in the courses laid down for commercial obligations and schedule upkeep can at times reduce safe margins to danger & precautionary areas. The problem of safety versus financial interests has always been there. Having due regard to the enormous burdens to be borne in aftermath of an accident may trim our decisions back on the safe track. A short cut will reduce steaming time by hours at most but grounding the vessel can bankrupt the owners and cost lives & sway careers jettisoned & awash.

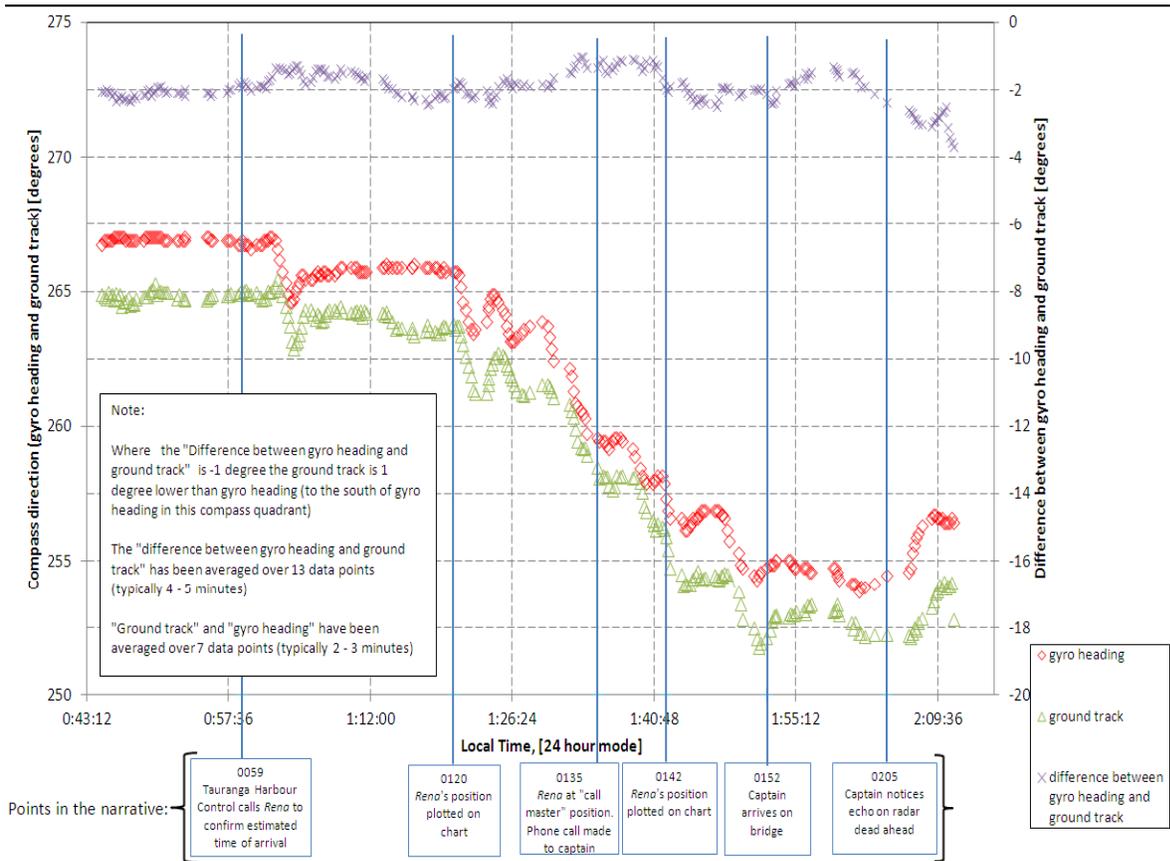
F) No systematic evaluation of drift was made. In the following figure having various data superimposed; it can be observed that the drift was growing to be gravely dangerous, but the navigators failed to perceive it. *Lack of proper workmanship*

- 2- Passing close to islands requires extra precautions; if not the most important; surely vital to check the positions more precisely & by other means. Cross-checking the positions is a task which should be practiced as a routine work. Had they been checking the positions more frequently & precisely as well as by other means; they would notice the drift at earlier stages.

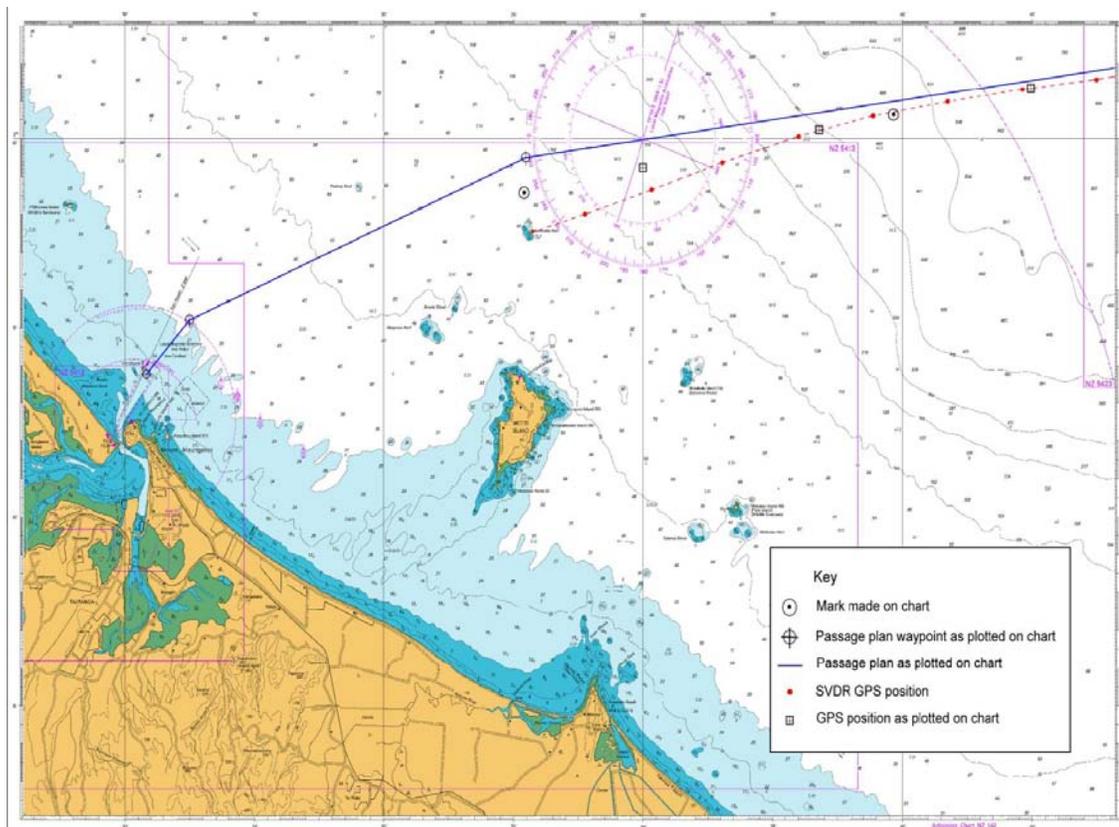
I) At 0200 the master and second mate were on the chart discussing the arrival arrangements (which was a few hours later) so the AB did not plot the position on 0200. *Mis-understanding & Mis-conceptions about the priorities in operations*
