**KISH P & I LOSS PREVENTION CIRCULAR KPI-LP-103-2013**  
***(Battery Damage due to Charger Failure & Lessons to be Learnt)***

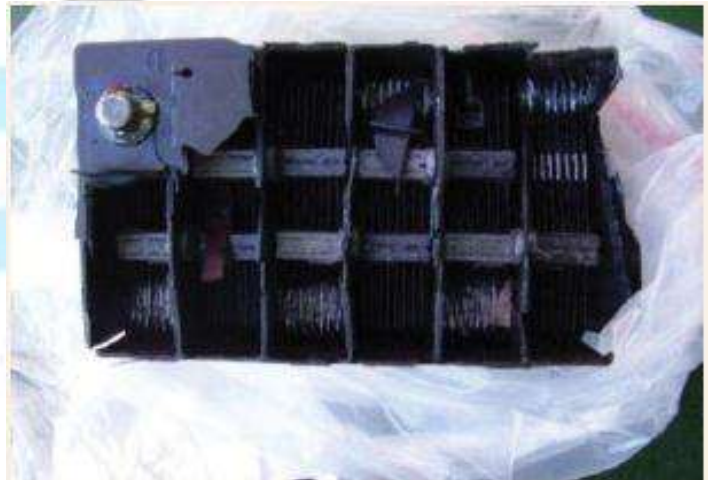
A ship's engineer was carrying out planned maintenance of the emergency generator. When he started the generator, he heard a loud bang from the battery container. On investigating, he discovered that one of the starter batteries had exploded, with the top of the battery detaching from the body. The battery was safely removed and the engine was temporarily left in the manual starting mode.

On investigation, it was discovered that for an unknown period of time, the vessel's emergency generator battery charging system was wrongly set up in such a way that two chargers could be charging the battery simultaneously. This resulted in excess evaporation of the water content in the electrolyte, substantially lowering the liquid level and exposing the plates. It is thought that internal arcing occurred across an air gap, triggering an explosion.

View of battery with shattered top

1. All charging systems should be checked to ensure that the charging current cannot

exceed the specified safe range;

2. All battery containers / receptacles should be checked for tightness of fixtures and overall integrity as part of the planned maintenance.
