KISH P & I LOSS PREVENTION CIRCULAR KPI-LP-120-2013 **(A Steering Failure & Lessons to be Learnt)**

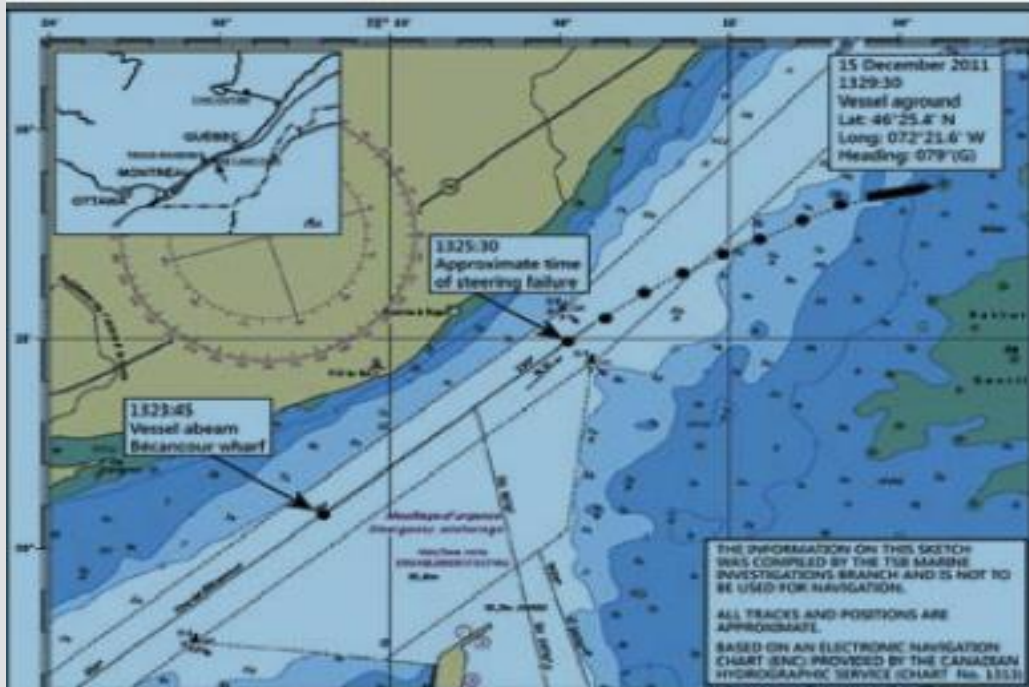
When the bridge team became aware that the rudder was not responding three options were available on the bridge to rectify the situation:

1. Taking over the steering control with the non-follow-up (NFU) mode,
2. Changing over from the port to the starboard steering system to also regain steering control, or
3. Stopping the vessel.
