KISH P & I LOSS PREVENTION CIRCULAR KPI-LP-126-2013 **(Accident caused by Off-centre Steering Position)**

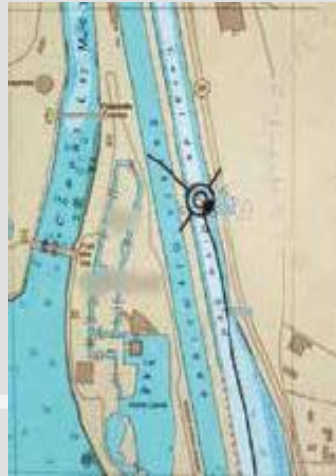
The vessel's pilot card showed a schematic diagram of the navigating bridge that portrayed it as symmetrical either side of the centre-line of the vessel. None of the documentation on the bridge indicated the important information pertaining to the conning and steering position, which was offset from the centre-line. As it was, the steering stand was almost three metres to starboard of the centre-line of the vessel. This resulted in a parallax error of approximately 1.6° to starboard if the line of sight is taken from the steering stand. The pilot was apparently aware that the steering stand was offset from the centre-line, but had estimated the potential error to be about 0.5°.

1. Neither the offset steering stand from the centre-line of the vessel nor specific and detailed information

such as parallax error were provided to the pilot.

Additional Note: Having a complete and detailed Pilot Card is crucial. Both the offset steering position and resulting parallax error as well as the articulated flap rudder are very important facts that should have been known to everyone involved. Yet, what was not mentioned in the official report was the apparent lack of complete communication between the bridge team, a critical element in good BRM. For example, the

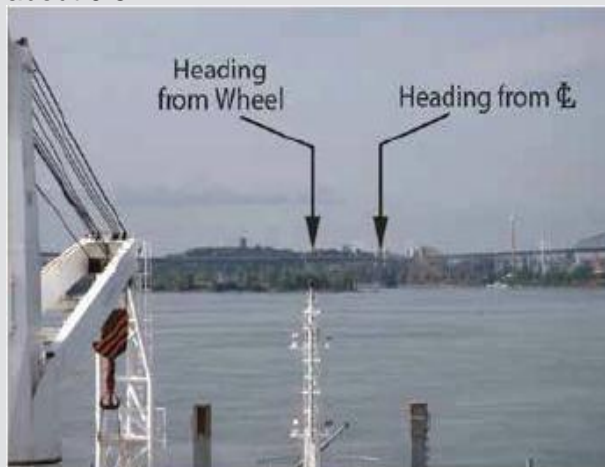
As the vessel cleared the lock the speed over the ground (SOG) was about 4 knots. The pilot then asked the Master to increase the pitch to 20% and requested the helmsman to steer on a heading of 353° gyro (G) to bring the vessel to the south of the channel centre-line. This manoeuvre was standard practice to compensate for the flow coming from the regulating channel, starboard of the vessel. A few minutes later the pilot ordered the helmsman to steer on the light in the middle of the bridge span ahead to bring the vessel back towards the centre of the channel. At this time, Traffic Control also informed the bridge team that the bridge pillars immediately either side of the channel were not illuminated.

later the pilot gave the helmsman orders to bring the vessel's head towards the north pillar of the bridge, which was not illuminated but was visible. Once the vessel was steadied on the pillar, the pilot found the heading to be 349.5°G and ordered the helmsman to steer 349°G (346° True). Since the course of the channel was 348°T, this heading would bring the vessel towards the centre more quickly. The pilot then reduced the pitch to 15%.

Shortly thereafter the pilot observed that the vessel was more to the south than expected, but this was not judged to be abnormal. He then reduced the pitch to 10% for the entry into the narrower part of the channel ahead. As the vessel entered the restricted part of the channel with a SOG of 6.8 knots and a heading of 350°G the helmsman had to apply starboard rudder to keep the vessel on the desired heading (an indication of bank suction astern). Shortly thereafter the vessel's course took a sudden sheer to port. Immediately, the pilot ordered the rudder hard to starboard and requested that the Master activate the bow thruster. The pilot used the CP propeller lever to produce an engine kick ahead and then set the CP propeller lever at full astern but the vessel continued crossing the channel at a 45° angle.

The vessel's bow subsequently grounded on the north bank of the channel some 0.75 nautical miles downstream from the lock they had just exited, the stern to the south side of the channel thereby blocking the waterway; vessel traffic was interrupted for approximately 10 hours until the vessel was successfully refloated.
