## **KISH P & I LOSS PREVENTION CIRCULAR KPI-LP-127-2013** ***(Another Reason for Less Speed in Heavy Weather)***

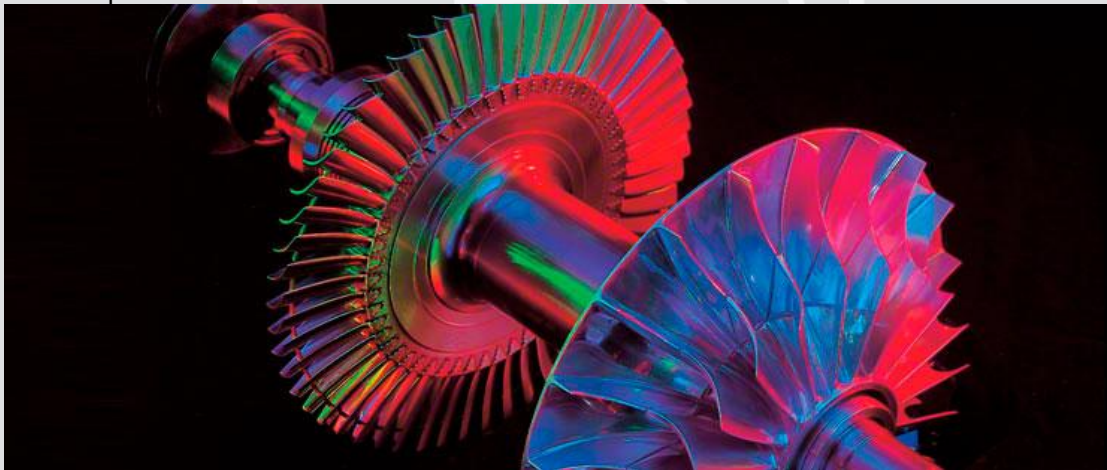
1. Turbine blades worn oval on half the wheel profile.

2. Turbine side shaft labyrinth deeply grooved and worn undersize and the shaft bent at the turbine end journal.
3. Turbine end journal bearing was subjected to extreme heat and had turned blue.
4. Shaft bent at the compressor end journal.
5. Compressor impellor worn oval on half the wheel profile.

Given the above findings the rotor assembly was not repairable. The rotor assembly required replacement, along with a few other parts.

Damage to the turbocharger took place due to excessive wear of the turbine side bearing, thereby losing the centre line of rotation. On the whole, the components in the radial direction were found damaged.

1. Reduce main engine speed if surging occurs. If further reduction requires changing over engine to diesel oil, this should be carried out and the charterers and owners advised.
2. Ensure main engine lubricating oil purifier is working well.
3. Ensure bypass filters and turbocharger lubricating oil filters are clean.
4. Carry out routine marine grit cleaning on the turbine side.
