KISH P & I LOSS PREVENTION CIRCULAR KPI-LP-137-2013
(Ergonomics & Mooring Winch Operation)

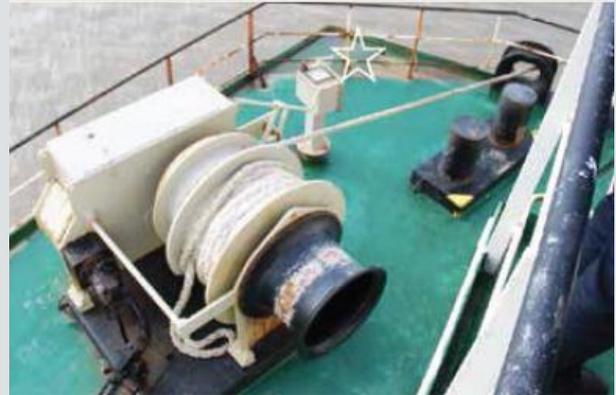
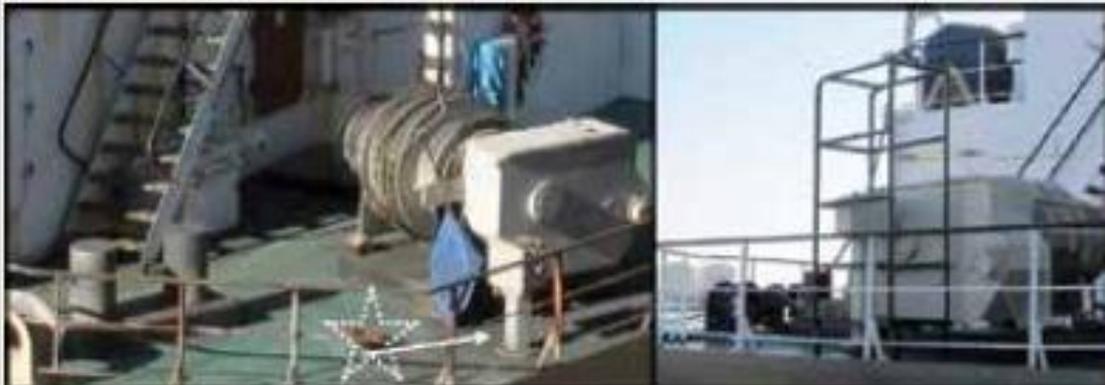
At the same time, the slack on the starboard stern line was taken in by a crewmember on the starboard side, alone and without a VHF radio (his position indicated by white star above). Initially, the crewmember pulled the slack from the line on deck by hand. After that, he began to haul in the section of the stern line now on deck with the winch. While doing this, he noticed that the slack on deck was beginning to form a loop, causing a risk of the line being wrongly-wound onto the drum. To counter this risk he attempted to

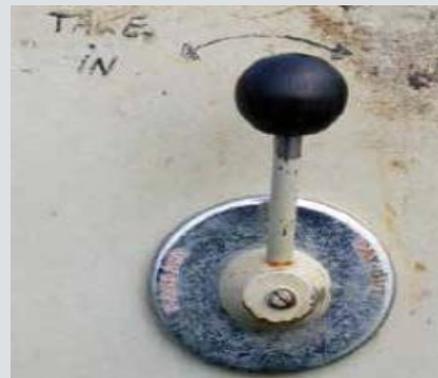
4. The accident shows that it is easily possible to confuse the winch's direction of rotation and that doing so can have serious consequences. The handwritten and only partially readable 'label' on the winch's control station shows that uncertainty with respect to the direction of rotation of the winch in relation to the respective lever position apparently also existed before the accident.

The control units of the winches on the stern of the vessel (and her sister ship) have been moved to a position further forward and each equipped with a safety cage for the winch driver.
