**KISH P & I LOSS PREVENTION CIRCULAR KPI-LP-25-2012**  
***(MARS Sampled Accidents & Lessons To Be Learnt)***

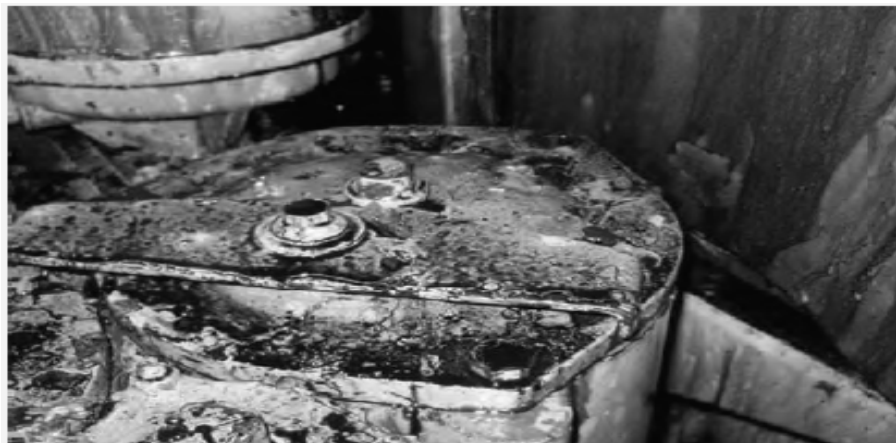
- 1-Sudden shearing off of one of the three bolts that secures the lubricating oil filter cover of A/E #2. The cover was displaced and lube oil under pressure splashed on to various hot components of both running generator engines and ignited;

View of displaced fuel filter cover

- 1-A special safety meeting was held on board to emphasise the importance of carrying out risk assessments, tool box meetings and discussing all the anticipated risks when allocating jobs for the day;
- 2-Anti-splash sheaths, guards for filter covers and extra securing arrangements for cover bolts were fabricated and fitted for all lube oil pipes and filters on generator engines; even though these are not formally required;
- 3-Renewal/cleaning of the filters and other critical parts of the generators will be supervised by the senior engineers;

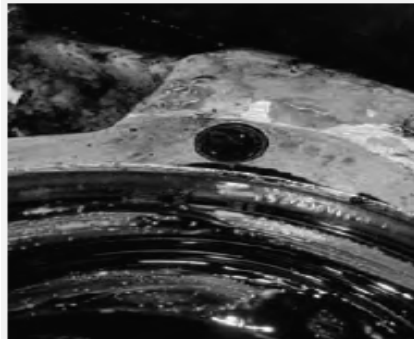
Close-up view showing sheared bolt of filter cover

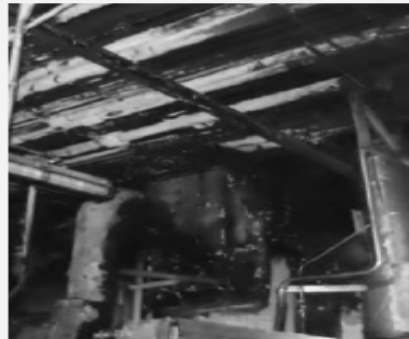
View of fire damage

- 4-Restoration of all engine room areas affected by the fire (coating renewal, renewal of damaged electrical wires and other associated fittings) was commenced immediately;
- 5-All auxiliary engines were made fully operational and successfully load-tested.

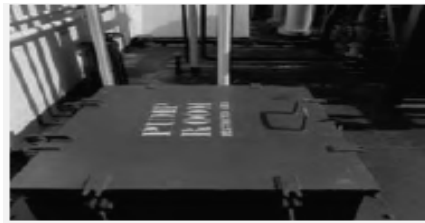
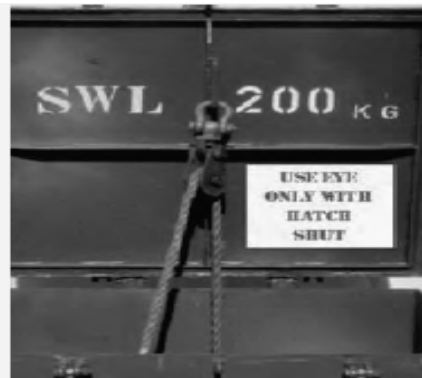
View of pump room hatch in shut position

Dedicated padeye on underside of hatch lid intended for use only when lid is secured in closed position

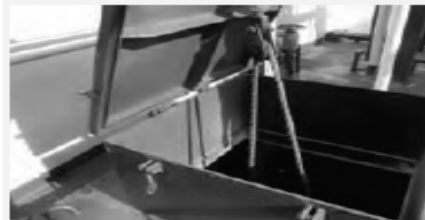
- 1-Inappropriate operation – the lid was fitted with a pad-eye of approved strength on the underside to be used for the lifting and handling of loads inside the pump room, but only with the lid properly secured in the fully closed position. In this incident, the crew not only failed to properly secure the lid in the open position, but wrongly used this fitting to lift loads out of the hatch with the lid held in the open position;
- 2-A single, non-standard pin (MS bolt without a check-nut) was used to secure the hatch lid in the open position. It is suspected that the bolt was not passed all the way through the lugs of the hold-back arrangement of the lid;
- 3-The crew failed to carry out a proper risk assessment, possibly because of the light loads (bundles of staging aluminium pipes) being handled.

Improperly secured open lid wrongly being used to lift loads

- 1-The incident was discussed at a special safety meeting;
- 2-All hatch lids were fitted with securing pins as per original specifications and these were permanently attached with keeper chains;
- 3-All hatch lid securing arrangements were painted yellow and a prominent warning stencilled on them to ensure that the lid is properly secured when in the open position;
- 4-The pad-eye on the underside of the hatch lid was similarly marked, specifying it is to be used only when the lid is properly secured in the fully closed position.

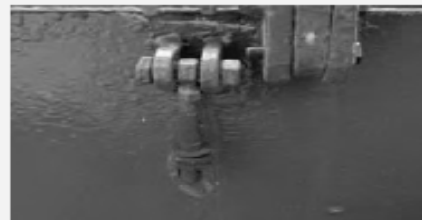
Non-standard bolt was used in place of a safer 'drop-nose' pin
