## **KISH P & I LOSS PREVENTION CIRCULAR KPI-LP-50-2012** **(Sampled MARS Accident Reports & Lessons to be Learnt)**

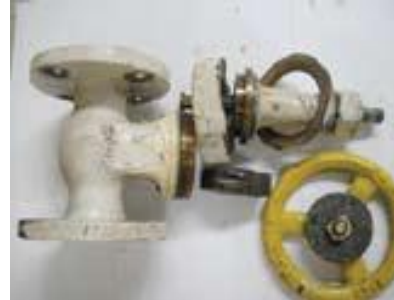
The team, led by the C/E, and comprising of the 3/E, J/E and an OS, entered the hydraulic machinery room and started the main pump motor. Without warning, the return line gate valve before the filter disintegrated and the detached bonnet flew through the air, hitting the J/E on his face and fracturing his skull and nose. He was immediately hospitalised ashore. Very fortunately, he narrowly escaped more serious injury that could have resulted in permanent damage to the eyes and brain and was able to recover fully from this accident.

**The Broken Valve**

During an earlier trial, it was noticed that one of the valve flanges next to the filter was leaking. After isolating the line, the crew renewed the gasket, and then opened the valve before the filter, but forgot to open the one after the filter. When the pump was subsequently started, the sudden build up of high pressure on the upstream side of the valve resulted in its violent disintegration.

- 1-The second valve (after the filter) was considered redundant. It was removed and replaced with a spool piece, reducing the risk of the inadvertent closure of the return line;
- 2-A sign was permanently installed next to the hydraulic pump motor starting switch warning personnel to "Ensure all return line valves are fully open"
- 3-The dangers involving work with high pressure system & lines should be reiterated and explained during various ship board drills & training sessions.

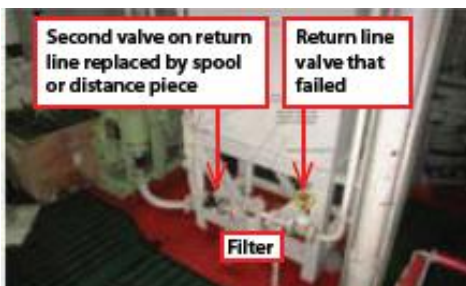
**Redundant valve replaced by Spacer Pipe**

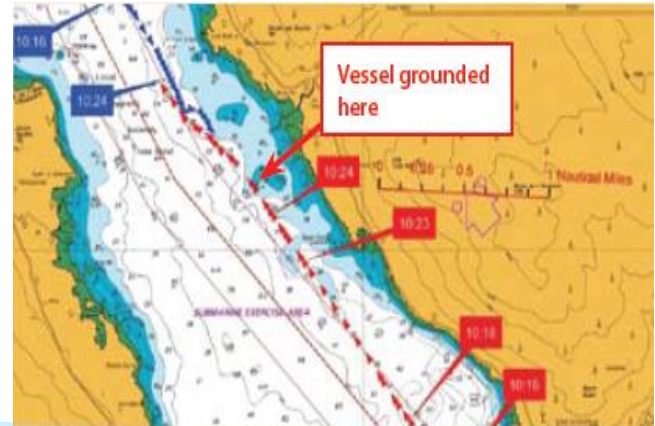
2-Before reaching the waypoint, the 3/O wrongly assumed that risk of collision existed with the sailing vessel on the next planned heading and prematurely initiated a turn to starboard and then continued to alter course to starboard, illogically intending to pass between the sailing vessel and the steep-to shore;

3-After initiating the course alteration, the 3/O did not monitor the vessel's position and projected track on the ECDIS display-for over 15 minutes- and failed to notice that the visual grounding warning alarm had been activated;

Track of vessel (in red) showing planned track, unchecked deviation to starboard, site of grounding, subsequent track recovery and near-miss with incoming sailing vessel (in blue).

i. Repositioned the main ECDIS unit adjacent to the starboard radar, enabling its viewing while facing forward;

ii. Reconnected the ECDIS unit to the bridge alarm monitoring unit to provide a functioning audible alarm;
