## **KISH P & I LOSS PREVENTION CIRCULAR KPI-LP-68-2013** **(MARS Jan-2013 Accidents & Lessons to be Learnt)**

### **► Accident no.1-Crew injuries from oil heater explosion:**

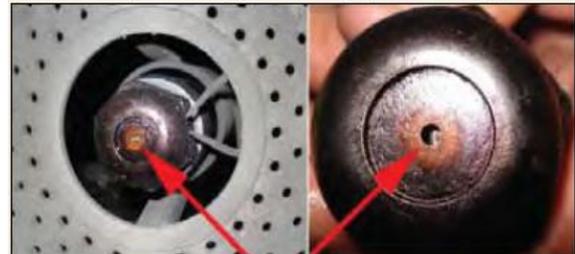
- 1-The burner nozzle had been incorrectly assembled, probably during the several investigation and repair attempts. As a result, the needle valve stem became bent and due to an improper seal, the circulating fuel continued to spray into the furnace during the pre-ignition start sequence;

Needle valve spindle damaged due to improper re-assembly

- 1 The ship's operator renewed the burner units for both oil-fired heaters and altered the control system to better suit the fuel being used and the load demands placed on the heaters;
- 2-The heater makers reviewed and amended relevant sections of the equipment service manual and relayed the incident details to ancillary equipment suppliers, including the burner equipment manufacturer;

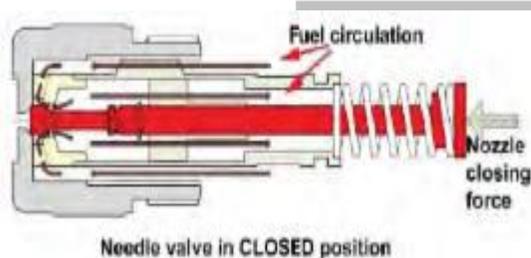
Nozzle with needle valve in OPEN position
