KISH P & I LOSS PREVENTION CIRCULAR KPI-LP-72-2013
(Accidents related to Fuel Leakage & Oil-soaked rag fire and Lessons to be Learnt)

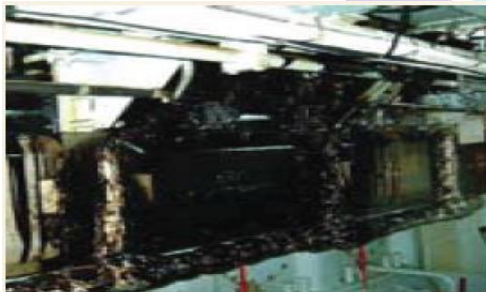
A product tanker was proceeding on a long voyage after the completion of dry-docking and associated surveys. During the ocean passage, the fire alarm was suddenly activated in the engine room. Instead of a fire, the cause of the alarm turned out to be a large leakage of fuel oil from a flange on the inlet pipe of the main engine no. 4 fuel injection pump.

Fuel oil leakage at camshaft side

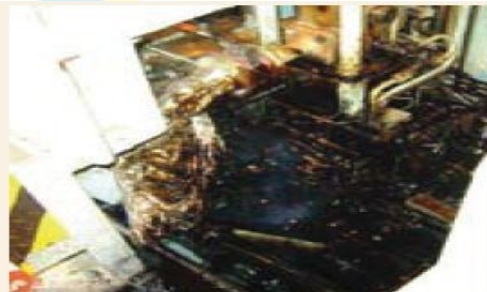
Fuel oil leakage on fuel pump side

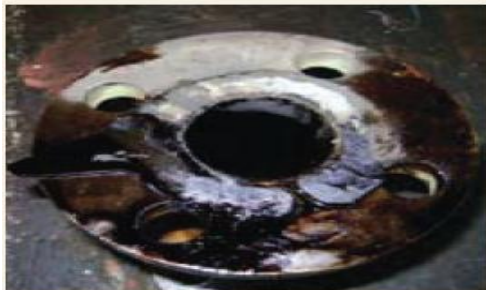
- 1-The fuel system had been overhauled, but no senior ship's engineer supervised its refitting in dry-dock. As they did not have a new spare, the yard workers had reused the gasket of the flange connection on the suction side of the fuel injection pump even though it was damaged;
- 2-The insulation and leakage containment cover over the fuel line had not been renewed/refitted.

Reused torn gasket that caused the leak at the flange connection

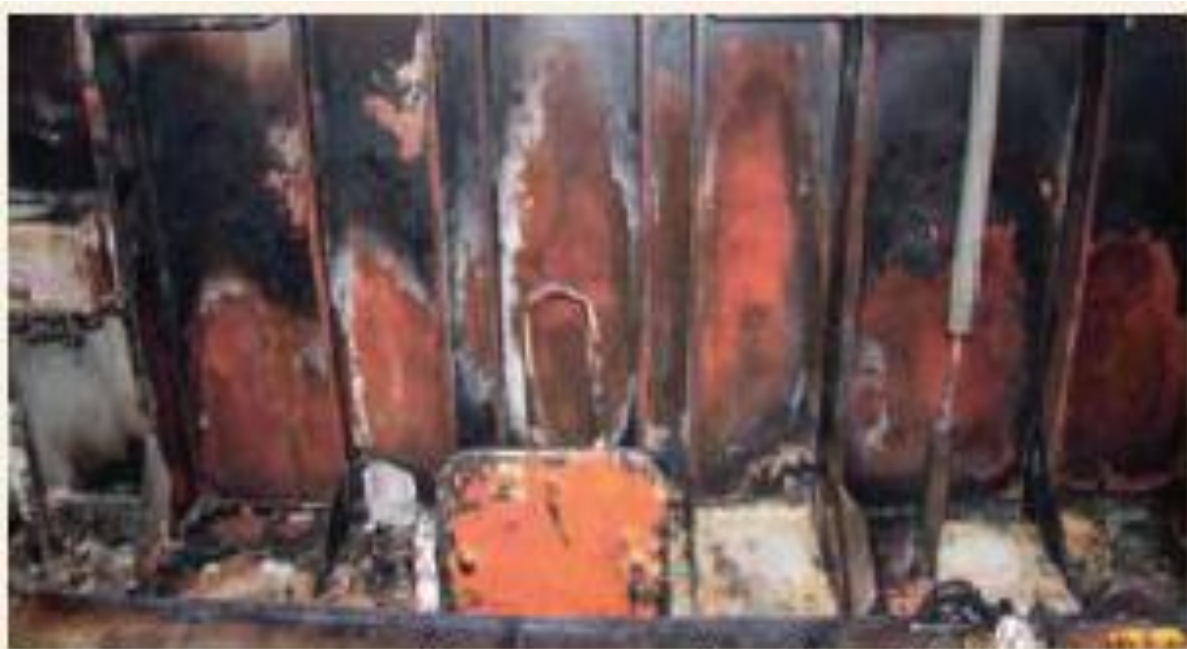
Earlier during the voyage, linseed oil had leaked from a container that had been discharged at the previous port, after which the deck crew had mopped up the oil from the deck. It was intended to land the oil soaked material at the next port, so the crew had collected and stowed it on deck overnight on a rubber mat abaft the forward wave-breaker. The rags spontaneously heated to above the self-ignition temperature of the vegetable oil. The resulting fire caused substantial burn damage to adjacent electrical fittings and paintwork on the deck, vertical surfaces of the bulkhead and a ventilator cowl.

Fire damage to paint and fittings on wavebreaker and deck
