KISH P & I LOSS PREVENTION CIRCULAR KPI-LP-77-2012
(Falling overboard while preparing pilot ladder & lessons learnt)

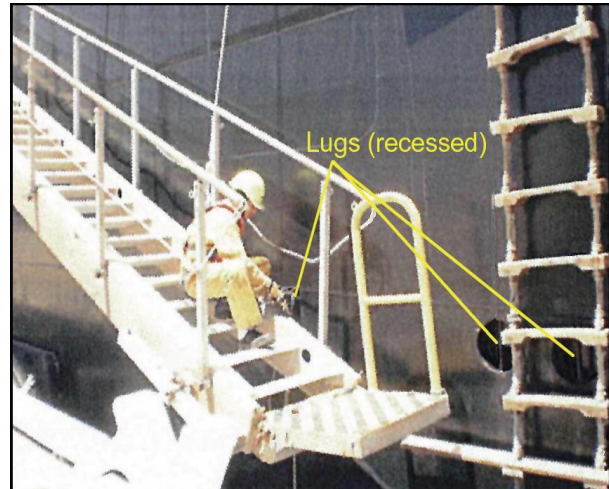
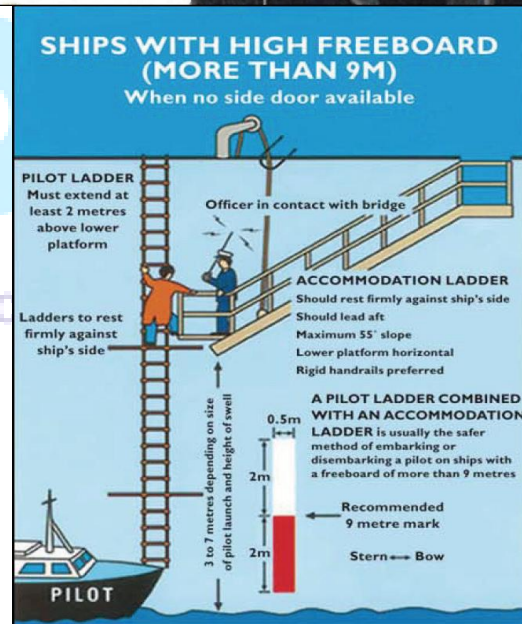
If a ship's freeboard is more than 9 m, a combination pilot ladder (refer to the figure) is required. Even with freeboards less than 9 m, combination ladders are often used because they are considered safer. However, since rigging a combination ladder involves working over the side, there is a higher risk of a crew member falling overboard while rigging it.
