## **KISH P & I LOSS PREVENTION CIRCULAR KPI-LP-82-2012** **(An Unberthing Accident & Lessons to be Learnt)**

► **Incident: Gangway damaged during unberthing**

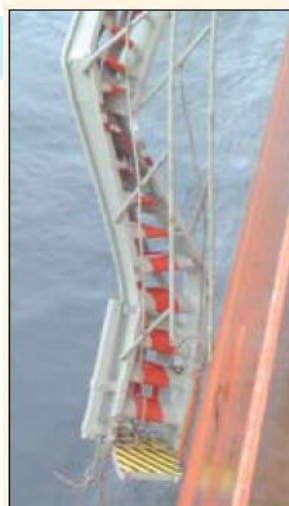
The vessel was to move from her berth (port side alongside) and tie up at another berth (starboard side alongside) further up the dock. A pilot and two harbour tugs arrived at the designated time and Master - Pilot information was exchanged before commencing the movement. The pilot requested that the port accommodation ladder be hoisted by only a few metres and retained there, as he intended to use it for disembarking from the 'sea' side at the next berth. Due to the ship's draught, height of the pier and the state of tide, in this 'raised' position, the gangway was only about a metre clear of the jetty. During the unmooring operation, there was a strong offshore wind and moderate rain, and due to the latter, both the Master and the Pilot remained inside the wheelhouse throughout. On the pilot's advice, all headlines and stern-line(s) were first let go, retaining only the back-springs fore and aft. After the stern-line(s) had been retrieved on board, the deck officer in charge of the aft mooring station went over to the back-spring winch, which was situated on starboard main deck, forward of the accommodation. He engaged the gear of the mooring winch and slackened the aft back-spring. From his location across the full width of the ship, the deck officer had no view of the quayside, and was relying on and responding to hand signals from an A/B stationed at the ship's port side. Due to the low clearance between the gangway and the jetty, the length and lead angle of the mooring line and the widening gap between the ship and the berth, the slack back-springs became fouled with the accommodation ladder and could not be cleared despite efforts by the shore mooring gang. The A/B indicated the dangerous situation by hand signals to the deck officer, creating some critical seconds' delay in responses and in communicating the information to the bridge. Once aware of the situation, the Master requested the Pilot to instruct the tugs to push the vessel back towards the jetty, but by the time this was done, the entangled gangway had been subject to severe axial, twisting and crushing forces and was severely damaged.

1. The Bridge team failed to effectively use the Pilot and tugs to retain the vessel alongside until all lines were retrieved, especially since there was a strong offshore wind;
2. The Bridge team failed to exercise basic seamanship and wear rain protective clothing and station himself on the bridge wing during the unmooring operations;
3. The unusual layout of the back-springs, gangway and low clearance over the berth should have precluded leaving the gangway suspended over side;
4. The deck officer at the aft mooring station wrongly assumed the role of winch operator, instead of directly supervising the operation and delegating tasks to his crew.

◀ View of damaged accommodation ladder

1. The master-pilot information exchange & coordination to be emphasized upon effectively;
2. Bridge team members & especially the master to position themselves appropriately on the bridge & wings as necessary during mooring and unmooring and closely oversee and control operations;
3. Adequate weather-protective gear to be always be available in the wheelhouse and other working areas;
4. Officer in charge of the mooring station to supervise the operation and effectively communicate with the shore and ship's staff and delegate tasks to the team;
5. It is advisable to heave up the accommodation ladders/gangways or any other hindrances during mooring/unmooring operations & actions of the incident type intended to save time may end up with expensive damages.

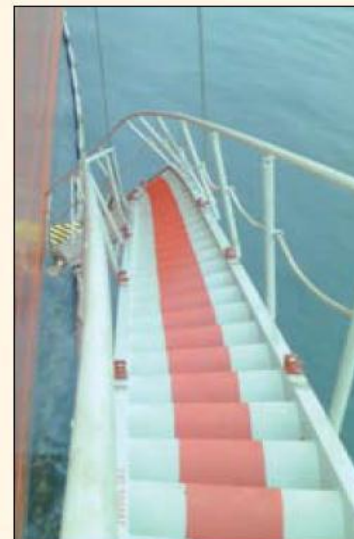
Another view ► of damaged accommodation ladder
