KISH P & I LOSS PREVENTION CIRCULAR KPI-LP-88-2012 **(Leaking Hydraulic Oil & Fire in Engine Room; Lessons to be Learnt)**

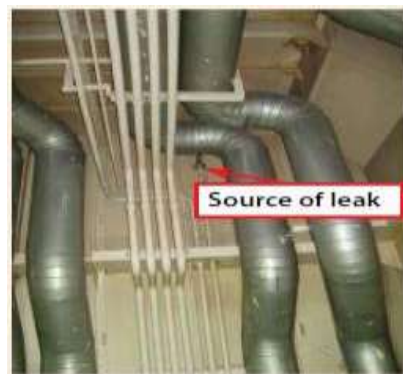
On a tanker on passage, the fire alarm suddenly sounded. At the same time, the engine room crew saw small flames and smoke rising from the after exhaust manifold and cylinder heads of the running main engine. After extinguishing the localised fire, it was discovered that hydraulic oil from the cargo pump system had leaked from a flange connection in the vent/overflow line situated directly above the main engine cylinder head platform.

- 1-At the previous discharge port, a submerged cargo pump hydraulic motor had malfunctioned. In preparation for carrying out repairs, an engineer had closed the vent-cum-overflow line valve located before the service/header tank without draining the line;
- 2-Due to the residual pressure in the line, the flange connection (later found to have loose fasteners) leaked and a fine spray of hydraulic oil began falling on the hot surfaces on the top of the exhaust manifold and ignited after attaining self-ignition temperature.

- 1-Inadequate work planning – line was not depressurised/drained before closing of valve before header tank;
- 2-Inadequate management of changes–the hydraulic piping had been modified some years ago to tap off a new branch line before the header tank leading to an offline oil filtering system. A stop valve was fitted without properly assessing risks;
- 3-Inadequate communication – the engineer who closed the valve failed to inform other members of this fact.

Flange joint on vent / overflow line with loose nuts located high above after exhaust manifold of main engine

- 1-Ship’s staff removed the stop valve from the vent line, and the piping was re-modified to ensure that the offline filtration circuit was independent of the vent/overflow line;
- 2-All joints in the hydraulic system lines were inspected for proper condition and tightness;
- 3-Sister vessels fitted with the same filtration plant were advised to check the lines to ensure that the overflow line could not be inadvertently shut. All vessels were instructed to thoroughly inspect all nuts and bolts on flange joints and tighten them.

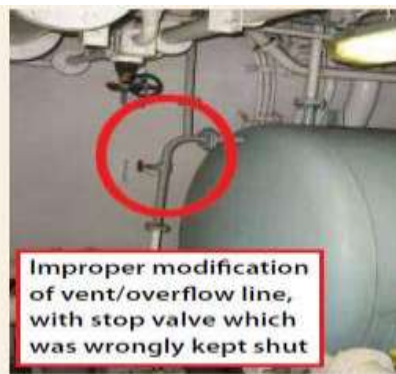
View of hydraulic header / service tank before corrective action
