KISH P & I LOSS PREVENTION CIRCULAR KPI-LP-94-2012 ***(VLCC colliding with Jack-up barge; Lessons to be Learnt)***

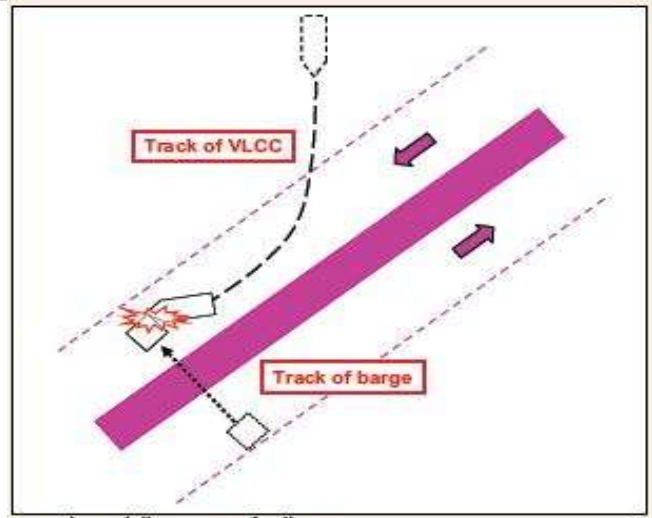
Hypothetical illustration of collision
