KISH P & I LOSS PREVENTION CIRCULAR KPI-LP-96-2012 ***(Fouling a Buoy after Loss of Propulsion; Lessons to be Learnt)***

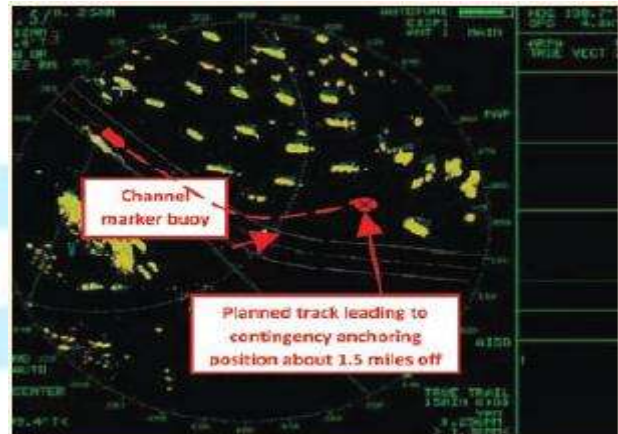
With a significant residual headway at the time of main engine shutdown, the Master was hoping to safely steer the dead ship along the track shown, leaving the buoy to starboard and anchor the vessel in the area north of the channel, clear of other anchored vessels

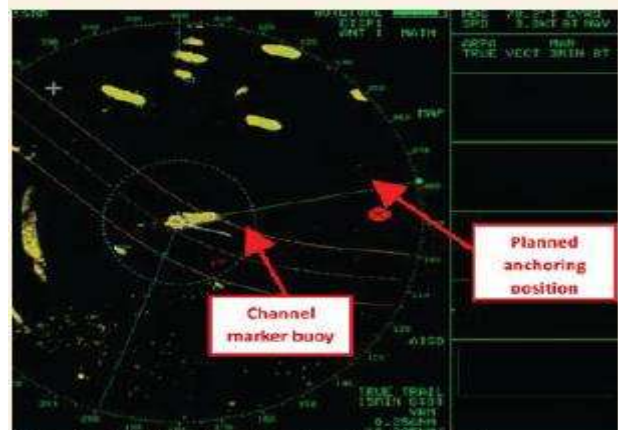
6. The approach to the contingency anchorage did not adequately consider the vessel's limited manoeuvring ability in very light ballast condition and the influence of the tidal stream;

7. The better option of passing the buoy to port before turning into the anchorage was overlooked.

The tanker drifted off the planned track and on to the buoy due to the easterly setting current and loss of steerage way (see true vector setting just south of east)
