KISH P & I LOSS PREVENTION CIRCULAR KPI-LP-97-2012 **(Remote Control can lead to Loss of Control in Lifeboat Drills)**

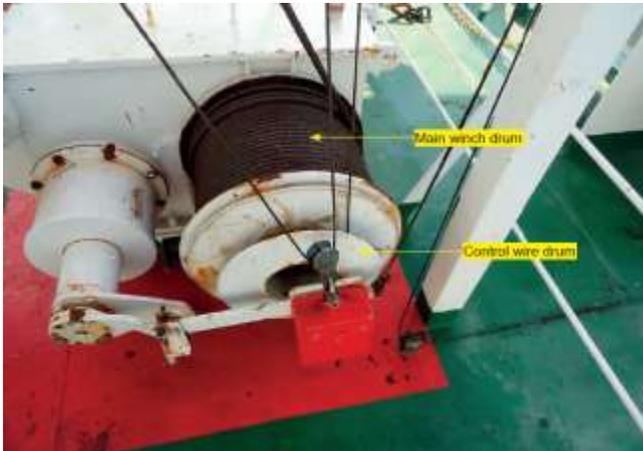
They could also be lowered from within the lifeboats by means of a control wire, which operated the brake control lever. The 4mm control wire was wound onto an auxiliary drum, which was connected to the main winch drum.

Importantly, the instruction manual stated that, during hoisting, the operator should assist in evenly distributing the control wire on the drum to prevent "bunching". The control

The intermittent application of the winch brake was caused by tension being taken off and then being re-applied to the internal control wire as the wire was paid out during the lowering process. This was due to a number of riding turns which had built up during the lifeboat's initial hoisting phase, partly caused by misalignment of the sheave closest to the control wire drum.

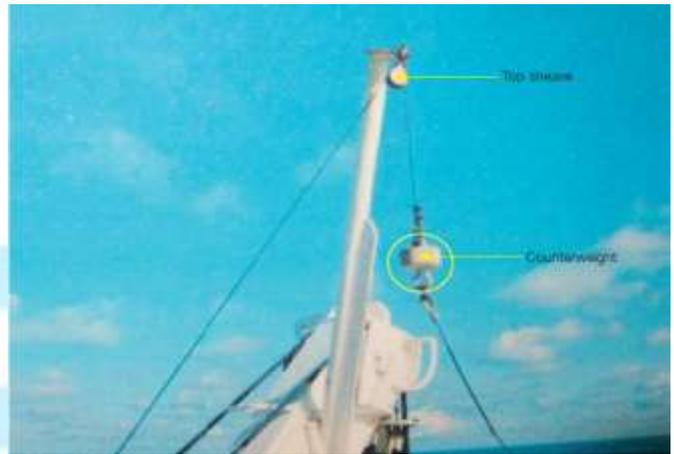
wire also passed through four sheaves before finally passing through the lifeboat's coach roof. Tension was maintained on the control wire by a 3kg counterweight which, according to the instruction manual, should be positioned approximately mid-way between the coach roof and the top sheave positioned at the davit head.

This position provided sufficient clearance between the sheave and counterweight when the lifeboat was being hoisted and when fully stowed. The control wire and top sheave arrangements are shown below:

As the control wire winch rotated, the riding turns were released, which caused additional control wire to be paid out. This caused the counterweight to fall onto the coach roof, which released tension on the brake, causing it to close.

As the lifeboat swung on the falls, the counterweight came clear of the coach roof, which tensioned the control wire, allowing the brake to release.

4. In this case, the instruction manual clearly stated that **careful attention must be paid to ensuring that the wire on the control wire drum was evenly distributed to prevent riding turns** and resultant uneven paying out. This was not considered, and was the root cause of this avoidable accident.

6. Control wires are often led through a number of sheaves, all of which have the potential for snagging the wire. **It is vitally important that the wires and sheaves are properly maintained to ensure freedom of operation and that alignment of the sheaves is checked where problems are experienced.**
