KISH P & I LOSS PREVENTION CIRCULAR KPI-LP-87-2012
(Engine Room Fires are the main cause of most fires on board)

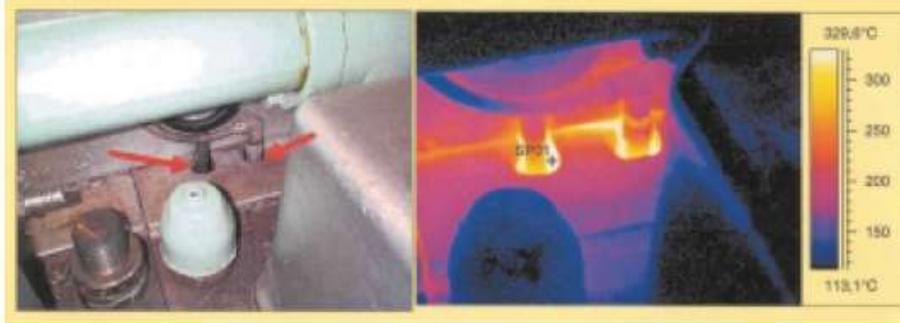
Most fuel oils may spontaneously ignite if they hit surfaces with temperatures above 250°C. Class rules require that all surfaces above 220°C are to be shielded or insulated. As commonly noted by inspectors and surveyors, such protection is often impaired under operation. Several methods can be used to detect hot surfaces.

The picture shows cylinder hoods and engine body (only 100°C) and cut out for sensors (more than 300°C).

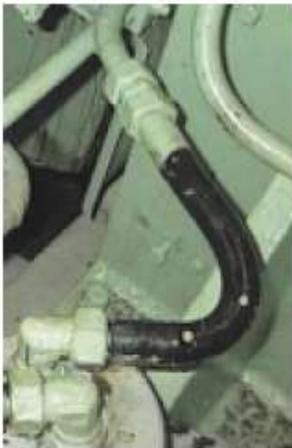
Flexible hoses should only be installed where necessary to absorb vibrations. Bends on oil hoses, sharper than that shown on this picture, should be avoided.

Sources of fuel leakage appear to be randomly distributed between flexible hoses, couplings, clogged filters and fractured pipes. Attention should be paid to installation, location and condition of all these components. It is recommended that oil systems within engine room on ships in operation are inspected periodically also by owner, as an addition to class inspections.
