## <u>KISH P & I LOSS PREVENTION</u> <u>CIRCULAR KPI-LP-159-2014</u> (Risky Crossing of Traffic Separation Scheme & Lessons to be Learn)

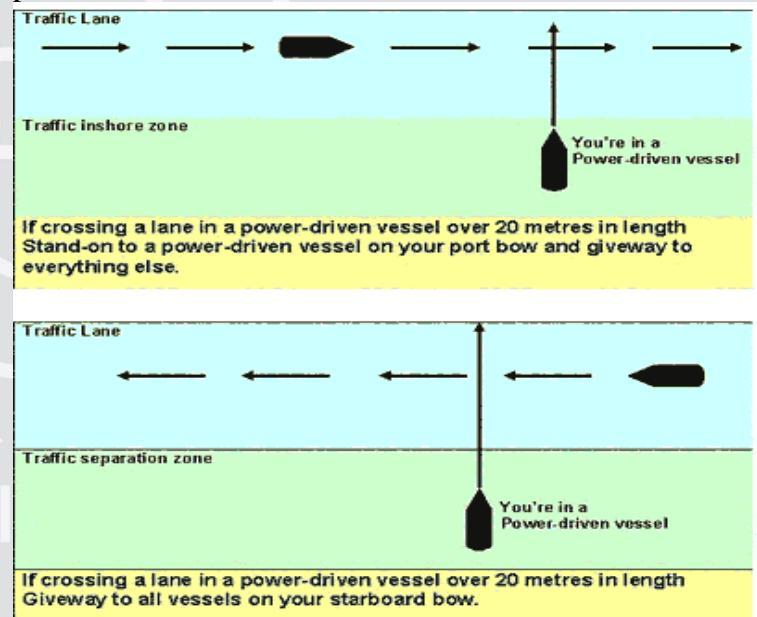
The cargo vessel stopped turning on a heading of 093 degrees (T) with the bulk carrier fine on her starboard bow at a range of 1.4 miles. She then slowly turned to starboard, keeping the bulk carrier on her starboard bow, and finally steadied on her planned course to cross the traffic lane.

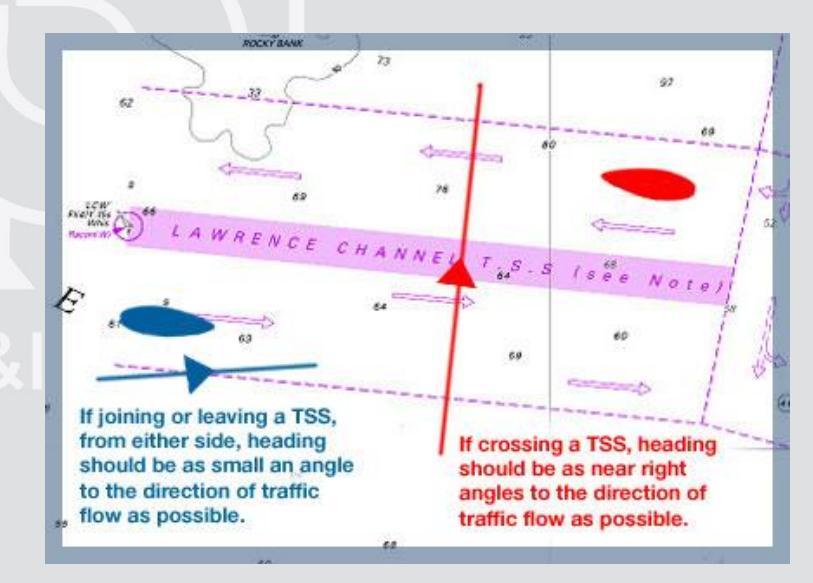
✓ Uncertainty might have been avoided if the cargo vessel's Master had effectively communicated his intended manoeuvre the to bulk carrier's OOW at a sufficiently early stage. In this case, the cargo vessel's Master made no attempt to convey his plan to the bulk carrier, and the VHF radio calls made by the bulk carrier's OOW were not received on board the cargo vessel owing to the speaker volume having been turned down. VHF radio transmissions are of no value unless they can be heard.
