KISH P & I LOSS PREVENTION CIRCULAR KPI-LP-131-2013
(A Pilot Ladder Accident & Lessons Learnt)

► **Pilot ladder gives way:**

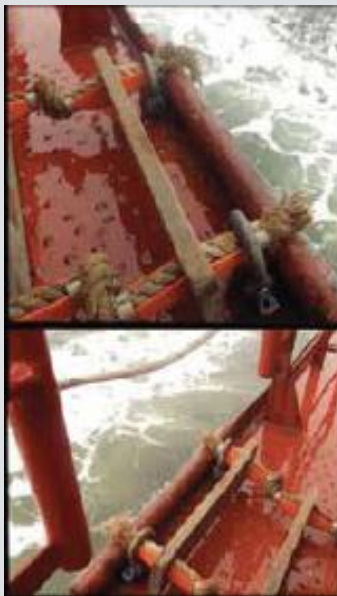
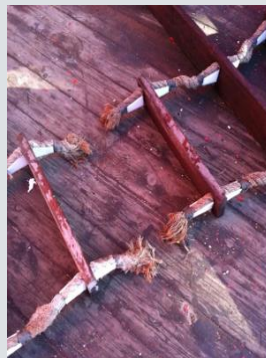
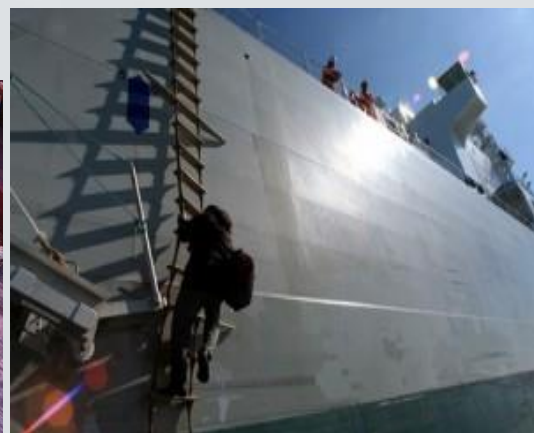
As soon as the pilot committed his full weight to the ladder, the ropes on each side of the ladder parted simultaneously at the point where they went over the rounded fishplate at the sheer-strake (see photos). The pilot fell two metres to the deck of the pilot launch, bruising and spraining his right foot and ankle which took the impact of the fall. His injuries could have been much worse had the freeboard of the vessel been greater.

The root cause of the accident was the failure of the pilot ladder due to inadequate maintenance and inspection.

Accidents due to inadequate pilot ladders or their installation, totally preventable, happen with alarming frequency. There really is no excuse for unsafe pilot ladders on board ships.
