KISH P & I LOSS PREVENTION CIRCULAR KPI-LP-42-2012

(Mooring Accidents Analysis & Lessons to be Learnt)

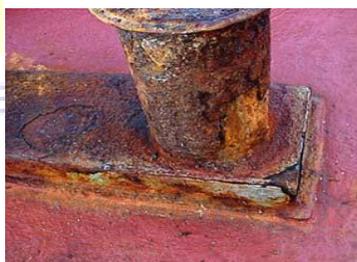
Mooring equipment that has suffered severe wastage will not perform to the certified standard. This also applies to the steel to which the equipment is welded. The first image shows mooring bitts that are badly wasted. The deck is in equally bad condition and there is a danger of the bitts being torn from the deck. The other two images show very badly maintained old (dead) man pedestal fairlead.

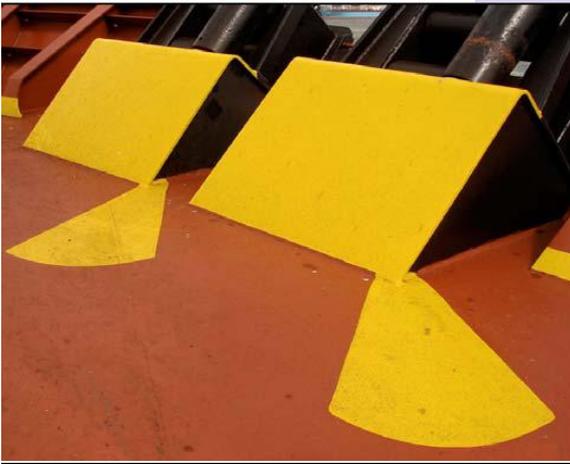
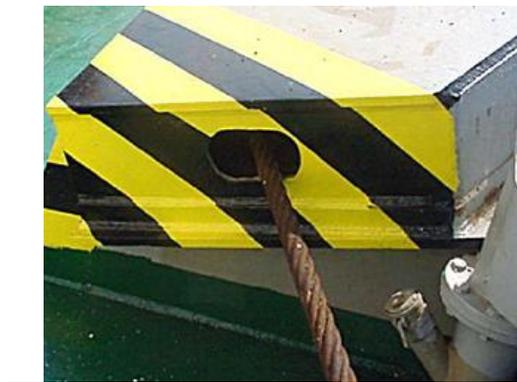
When a line under tension parts, it will whip back to the remaining point of tension.

If snap-back zones are painted on the deck then crew will be alerted to the danger when they notice they are standing in a highlighted zone.

Highlighting mooring line snap-back zones ensures that crew can visibly see the danger areas without having to purposely think about them while working.

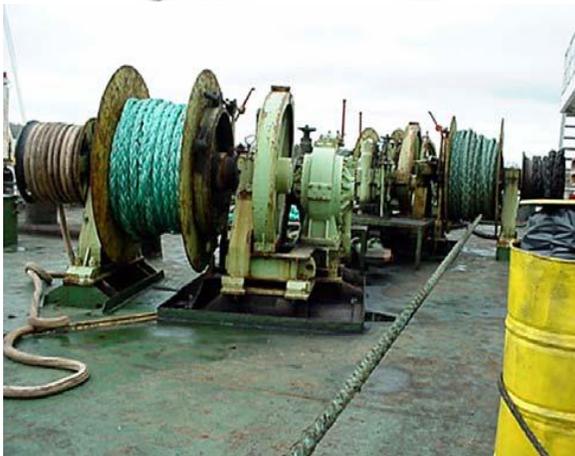
Bights don't always look like bights. Here a seaman has inadvertently stepped over the line and put himself at risk.

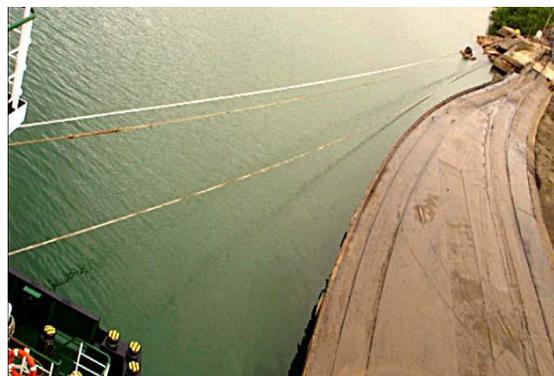
The image below shows a vessel considerably overhanging her berth. She is therefore unable to lead any stern lines aft of the ship. The image shows one line in particular being lead an extremely long distance, rendering it pretty much useless.

The ship has correctly put out as many lines as possible but should also consider the use of the anchor and mooring lines running aft from either the main deck or other suitable areas.

In situations like this it is important to analyse local tidal and weather patterns in order to predict how the vessel will be affected. The owners should be informed and cargo operations stopped (or not commenced) if conditions do not appear safe.

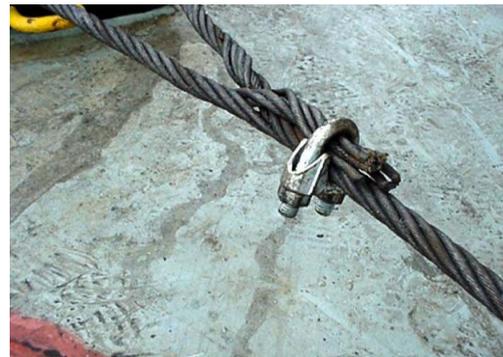
WRONG

- The grips must all face in the same direction and must be fitted with the saddle or bridge applied to the working or hauling part of the rope. The U-bolt must be applied to the tail or dead-end of the rope. If the grips are not applied as indicated above, the effectiveness of the eye can be seriously affected.

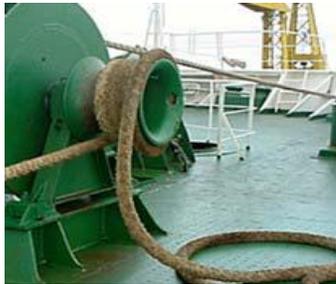
Bad practice

It is a general practice to place the forward ropes in the forward stores but the aft ones usually remain outside. This is not a good housekeeping. The ropes which are laid in open air; will be affected by sunlight and possible water sprays. They may come in contact with various chemicals like deck-wash which in the passage of time will cause degrading of the ropes.
