KISH P & I LOSS PREVENTION CIRCULAR KPI-LP-92-2012 (An Anchor Dragging Incident & Lessons to be Learnt)

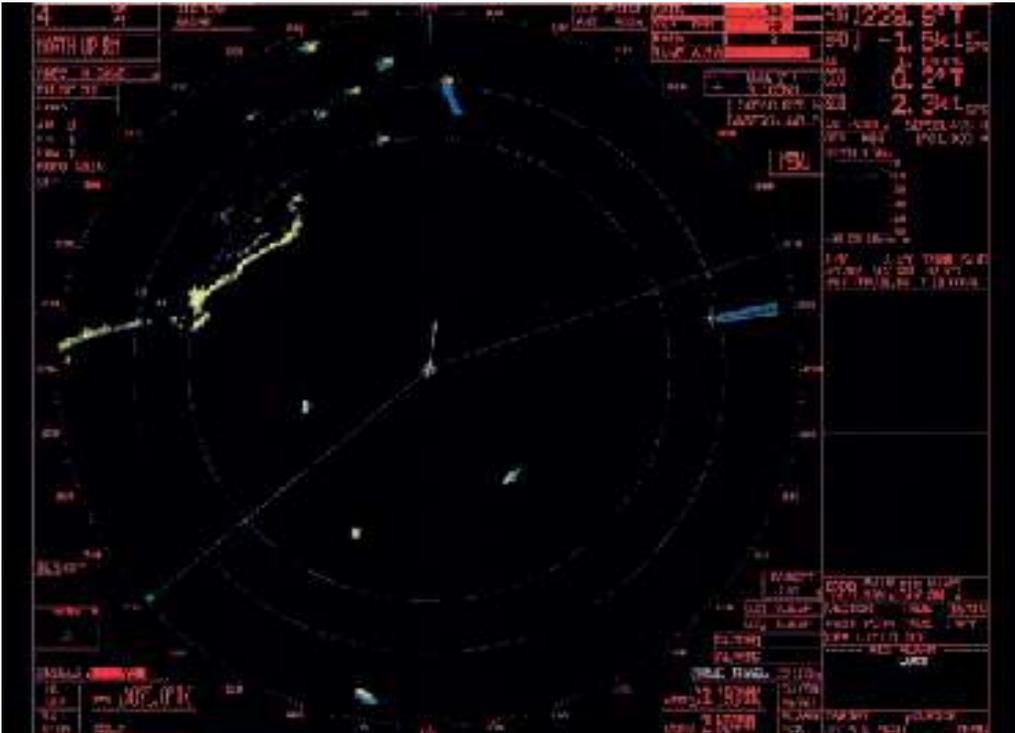
The product tanker remained at anchor. In the early hours of the morning the ship started to drag her anchor towards the shoal patch. This had not been detected by the OOW, who was monitoring the ship's position using only a single radar range and bearing line from a fixed beacon.

The extracted AIS Data & ship's position

2. The position of the anchor had not been plotted, and no swinging circle had been drawn on the chart. The method used to warn if the vessel was dragging anchor was ineffective.

Plotting the anchor position and estimating a bridge swinging circle is necessary to determine whether a vessel is dragging anchor. The Admiralty Manual of Navigation, Volume 1 provides best practice for plotting a ship's swinging circle at anchor.

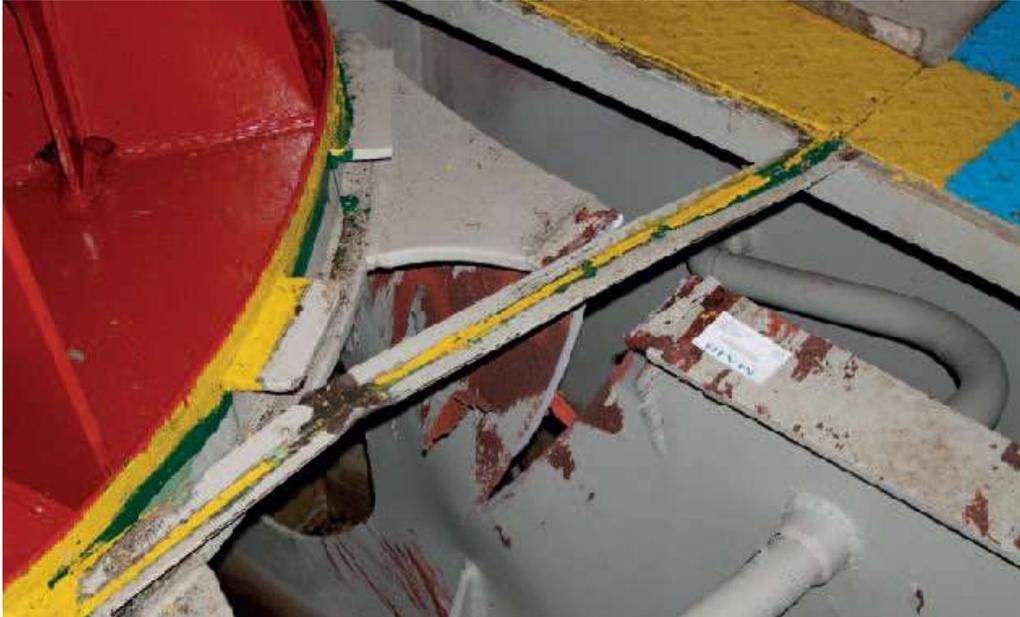
The ship grounded stern-first onto the shoal around 30 minutes after starting to drag anchor, and pounded onto the rocky bottom several times as it pitched in the heavy seas.

The rudder was put out of action and indicated on the bridge that it was hard-over. The port authority sent a tug to assist, however the ship continued to drag her anchor until the wind finally abated and the anchor held in deeper water on a rising tide.

The ship sustained significant damage to the shell plating along her length; the hull was heavily indented, but it was not breached and there was no pollution. The rudder and the steering compartment were badly damaged.

The damages to the steering compartment

7. The master's use of the engine was insufficient to stop the ship's progress towards the shoal. If the master had mobilised extra personnel to assist him on the bridge, and the engine had been placed at full power ahead, the accident might just have been avoided.
