## **KISH P & I LOSS PREVENTION CIRCULAR KPI-LP-127-2013** ***(Another Reason for Less Speed in Heavy Weather)***

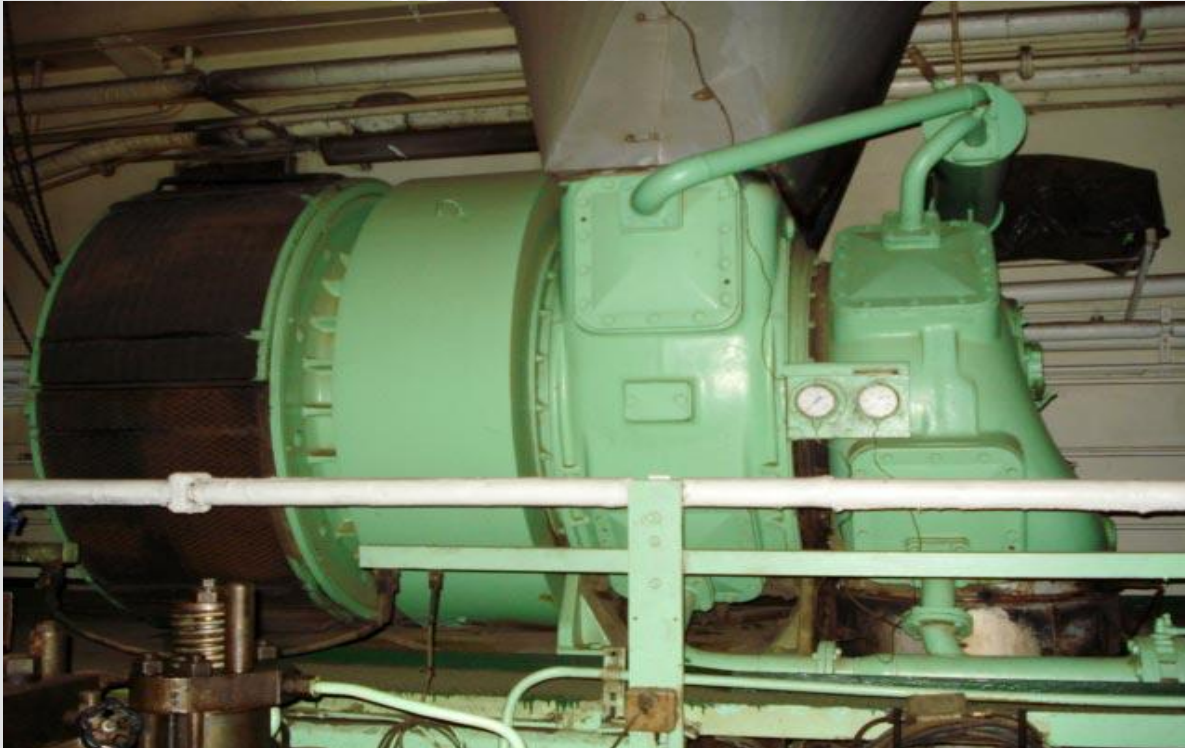
1. Turbine blades worn oval on half the wheel profile.

2. Turbine side shaft labyrinth deeply grooved and worn undersize and the shaft bent at the turbine end journal.
3. Turbine end journal bearing was subjected to extreme heat and had turned blue.
4. Shaft bent at the compressor end journal.
5. Compressor impellor worn oval on half the wheel profile.

Given the above findings the rotor assembly was not repairable. The rotor assembly required replacement, along with a few other parts.

Damage to the turbocharger took place due to excessive wear of the turbine side bearing, thereby losing the centre line of rotation. On the whole, the components in the radial direction were found damaged.

The constant load change caused surging of the turbo charger and the lubricating oil could have developed high soot levels caused by the increased piston blow-by (main engine being a trunk piston design) during the load changes.

circumstances which the vessel had experienced can cause high soot levels to build up very quickly. The soot would most probably act as a grinding agent and increase bearing clearances.

1. Reduce main engine speed if surging occurs. If further reduction requires changing over engine to diesel oil, this should be carried out and the charterers and owners advised.
2. Ensure main engine lubricating oil purifier is working well.
3. Ensure bypass filters and turbocharger lubricating oil filters are clean.
4. Carry out routine marine grit cleaning on the turbine side.
