**KISH P & I LOSS PREVENTION CIRCULAR KPI-LP-25-2012**  
***(MARS Sampled Accidents & Lessons To Be Learnt)***

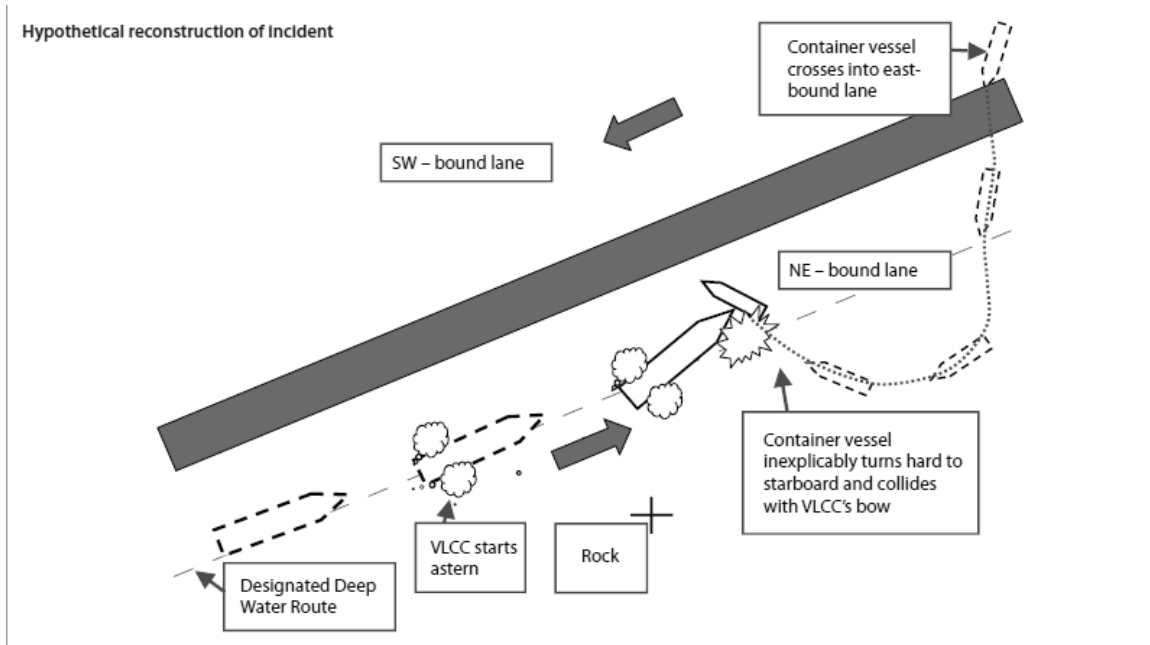
With vessel's engine still going astern, the rogue vessel crossed about half a mile ahead. Immediately after crossing, she inexplicably began to alter course hard to starboard and turn back towards the VLCC. Reacting quickly, the Master, whilst maintaining the full astern propulsion, ordered the rudder hard to port and repeated the Rule 34 (d) sound signal, but the container vessel continued to alter her course to starboard and, on a NWly heading, was heading directly for VLCC tanker's bow. With the ship still making headway, the container vessel's port quarter came into contact with the bow. The collision resulted in multiple indentations on the vessel's bow area and a breach in the container vessel's port bunker tank, resulting in an oil spill.

6-The manoeuvres implemented by our Master were considered to be the most appropriate under the circumstances, but due to the wrong actions by the other vessel, contact could not be avoided.

- 1-Violation of COLREGS Rules 5 (Lookout), 8 (Action to avoid collision),10 (Traffic separation schemes), 17 (Action by stand on-vessel) and 18(Responsibilities between vessels) by rogue container vessel;
- 2-Residual headway of own vessel despite the emergency full astern manoeuvre.

- 1 A navigational audit was carried out by the attending marine superintendent and all the staff were re-briefed on the company's procedures for safe navigation;
- 2-The superintendent also assessed the Master and found him capable/competent to complete the voyage and continue sailing on the vessel;
- 3-A flag state investigator visited the vessel at the discharge port to carry out an investigation and to review navigational procedures;
- 4-On the return west-bound ballast voyage, permanent repairs were carried out to the satisfaction of class.
