## **KISH P & I LOSS PREVENTION CIRCULAR KPI-LP-68-2013** **(MARS Jan-2013 Accidents & Lessons to be Learnt)**

### **► Accident no.1-Crew injuries from oil heater explosion:**

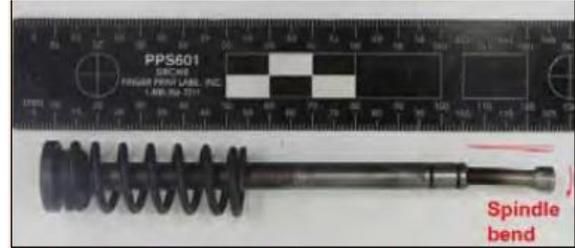
- 1-The burner nozzle had been incorrectly assembled, probably during the several investigation and repair attempts. As a result, the needle valve stem became bent and due to an improper seal, the circulating fuel continued to spray into the furnace during the pre-ignition start sequence;

Needle valve spindle damaged due to improper re-assembly

- 1 The ship's operator renewed the burner units for both oil-fired heaters and altered the control system to better suit the fuel being used and the load demands placed on the heaters;
- 2-The heater makers reviewed and amended relevant sections of the equipment service manual and relayed the incident details to ancillary equipment suppliers, including the burner equipment manufacturer;
