KISH P & I LOSS PREVENTION CIRCULAR KPI-LP-97-2012 **(Remote Control can lead to Loss of Control in Lifeboat Drills)**

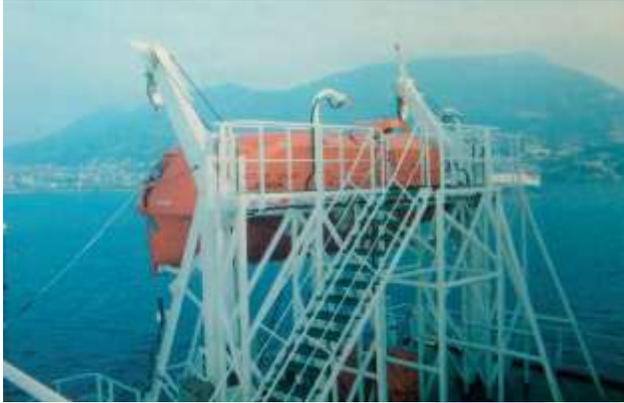
The port and starboard, totally enclosed lifeboats, which were not designed for use with bowing-in arrangements, were directly accessed from a raised platform on the deck.

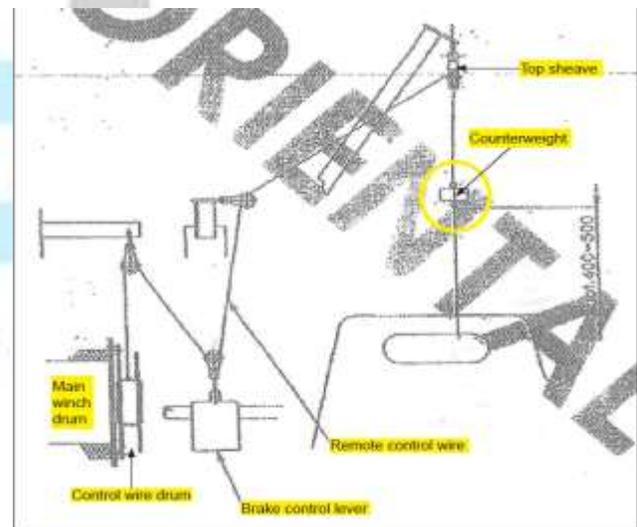
The intermittent application of the winch brake was caused by tension being taken off and then being re-applied to the internal control wire as the wire was paid out during the lowering process. This was due to a number of riding turns which had built up during the lifeboat's initial hoisting phase, partly caused by misalignment of the sheave closest to the control wire drum.

As the control wire winch rotated, the riding turns were released, which caused additional control wire to be paid out. This caused the counterweight to fall onto the coach roof, which released tension on the brake, causing it to close.

6. Control wires are often led through a number of sheaves, all of which have the potential for snagging the wire. **It is vitally important that the wires and sheaves are properly maintained to ensure freedom of operation and that alignment of the sheaves is checked where problems are experienced.**
