KISH P & I LOSS PREVENTION CIRCULAR KPI-LP-152-2014 **(Ineffective BRM & Lack of Communication Led to Collision)**

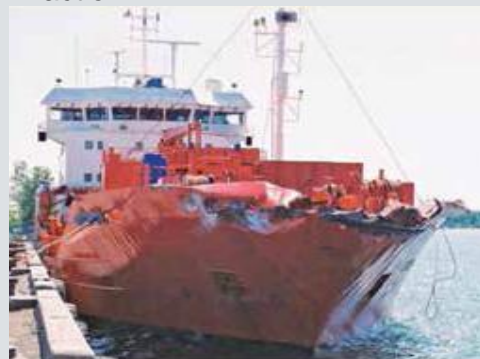
- ✓ The bank suction effect on vessel A became progressively more pronounced, requiring increasing starboard helm; placing the helm amidships caused the vessel to sheer to port.
- ✓ There was no relevant communication between the pilots of the two vessels throughout the developing situation.
- ✓ Ineffective Bridge Resource Management (BRM) aboard vessel A resulted in critical information not being shared with the pilot, thus precluding timely action.

For the next few minutes, more than 10° starboard helm was applied to maintain the heading on vessel A. Thereafter, 20° to 30° starboard helm was necessary to steer the desired course and, as the vessel had a flap type rudder, the helmsman was able to keep the required course of 248°. During this time, the pilot reportedly glanced at the rudder angle indicator from time to time, but there was no exchange of information among bridge team members. During this time the pilot gradually reduced the propeller pitch to slow the vessel down before the meeting. Since completing the bend at 7.6 knots, vessel A was now making 5.7 knots.

vessel A. The navigation personnel maintain that the pilot ordered the helm amidships, whereas the pilot does not recollect this order. The helm was nonetheless put to midships and the vessel immediately started to sheer to port. Full starboard helm was then applied, but the vessel's heading continued to swing to port. The two vessels collided near mid-channel at a combined speed of approximately 6 knots.
