**KISH P & I LOSS PREVENTION CIRCULAR KPI-LP-04-2012**

**Electric Kettle Fire**

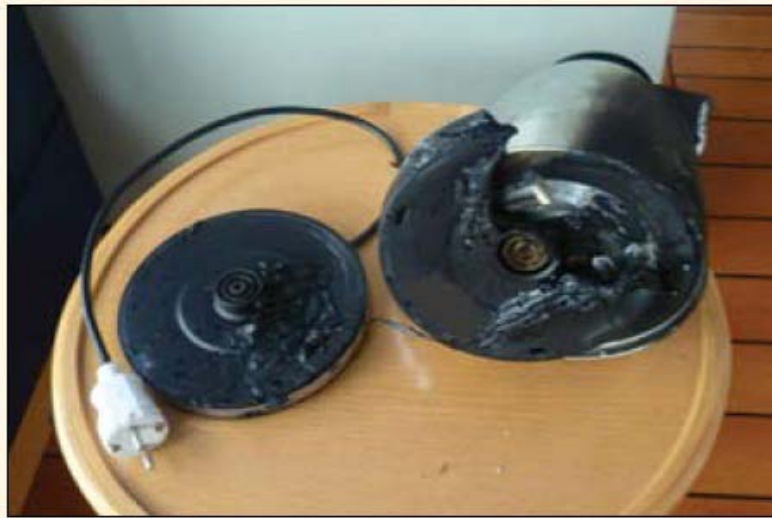
Some minutes later, all the water had evaporated and without any more heat load, the temperature rose high enough for the plastic base and kettle bottom to melt and ultimately catch fire. The strong smell of burning plastic drew the attention of a passing crewmember, who, after seeing the fire and smoke at the base of the electric kettle, quickly disconnected the power cord from the supply socket and transferred the burning kettle and base unit into the adjacent galley sink and turned on the water, successfully extinguishing the fire.

▲ View of fire-damaged kettle and base unit

The electric kettles being used on board typically consisted of a cordless stainless steel jug fitted with a plastic base that contained the electric heating element. Power is supplied via a male-female central connector mounted on the base unit, also made of plastic.

1. Automatic thermostatic switch malfunction;
2. Negligence on the part of the crew in not observing that the kettle was still boiling when they left the mess-room at the end of the coffee break.

- 1- The electric kettles supplied on board should be of approved standard & quality. They should be able to work on board with various tilting conditions and humidity ranges. There are very low quality kettles that the water is boiled through two plates with direct electrical connections immersed under water in the jug, which makes the equipment extremely dangerous. The electric kettles aboard many ships are not of the standard quality, hence extra care should be observed while using them;

- 2- The existing kettles on board should be checked for any sign of broken or damaged wires; connections and deformed plastic parts which may be a sign for extra heat. The heating elements might be covered with salt residues and ultimately help corroding the outer cover and water getting in direct connection with electricity causing short circuits, etc;

- 3- There should be prominent notices displayed near all electrical appliances requiring the disconnection of power cord from electrical supply outlet when not in use;

- 4- The use of automatic electric kettles involves following the maker's instructions. They should never be filled more than their capacity. The electric parts must not be immersed in water or so washed/touched by wet hand. The user should bear in mind that the automatic cut-off may not function due to variety of reasons, so a double check by senior officers or ratings and the attending mess-persons should be made;

- 5- The readiness of Fire Safety Systems on board is of utmost importance with respect to this & other similar cases. Having proper fire monitoring system components like smoke or heat detectors and employing fire patrol rounds as a part of every watch routine are deterrent criteria;

- 6- Using electric kettles in the cabins and non-public areas where proper monitoring is absent should be avoided as far as possible.
