KISH P & I LOSS PREVENTION CIRCULAR KPI-LP-138-2013
(Accident due to Corroded Wire-rope)

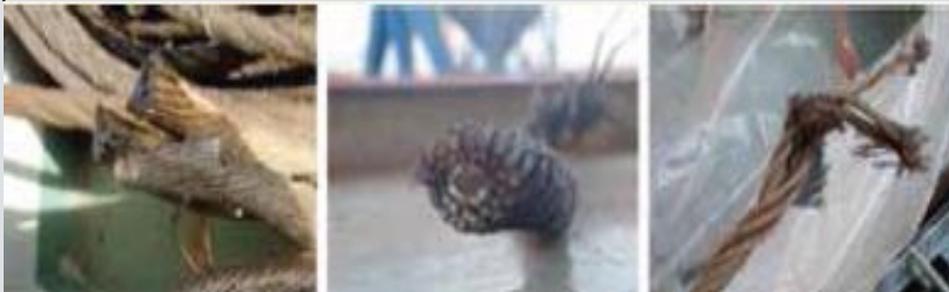
The wire rope had been installed a few years earlier and was inspected annually by a classification society surveyor, with the most recent inspection taking place two months before the incident. Despite this recent inspection, experts concluded that the wire failed as a result of serious local degradation of the wire in excess of the limits set by the classification society in their 'Rules for the Certification of Lifting Appliances On-board Ships'.

The degradation of the crane wire was attributed to the long-term lack of a suitable protective lubricant. It appeared that normal engineering grease was being used by ship's crew to lubricate the wire but that this had not penetrated to the core of the wire. Not only had this thick layer of grease failed to penetrate the core of the wire,

but the use of such grease meant that moisture had been trapped within the wire which accelerated the corrosion. In addition, the thick layer of grease made it hard to make a proper inspection of the wire.

Classification society surveyors can only spend a limited time on board looking at the whole ship and crew and shore staff must be aware that inspection of the crane wires may be visual only and will not usually involve a close-up examination of the core of the wire. In any case, crews should make their own ongoing and thorough assessment of the condition of ship's crane and derrick wires at regular intervals. In order to avoid corrosion of the core of the wire rope, a suitable penetrative lubricant should be applied.

Even if the correct type of lubricant is used, it is important to make sure that the wire ropes are always cleaned prior to lubrication to avoid the effects of marine salt and trapped moisture within the wire.
