KISH P & I LOSS PREVENTION CIRCULAR KPI-LP-95-2012 (Windlass damage when weighing anchor; Lessons to be Learnt)

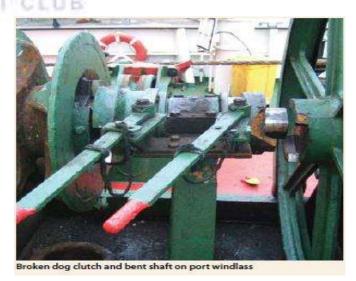
The decision was taken to get underway, and the starboard anchor was weighed. The crew then began to weigh the port anchor, using engines to reduce the load on the cable. The wind strength was increasing steadily and the windlass struggled to recover the cable when, suddenly and without warning, the dog clutch shattered and the cable ran out of control. Fortunately, no one was injured and the securing arrangement of the bitter end held. The cable was subsequently slipped and the vessel was taken out of service due to the damage to the windlass and the loss of her anchor.

- The selected location for anchoring did not provide sufficient shelter to prevent the vessel's anchoring equipment from being subjected to excessive loads;
- The guillotine bar's locking pin had not been engaged;
- The vessel's SMS for anchoring operations contained no reference to the use of the locking pin when anchoring;

4) The severe yaw that developed was due to the windage of the vessel's superstructure, which generated forces in excess of the design load of the anchoring equipment.

- •Owners and operators are strongly advised to review their SMS procedures for anchoring to ensure they address the above safety issues and, specifically:
- That masters have clear guidance on the capability of their vessel's anchoring system, including any limitations of the anchor system components, including that of the windlass;
- Effects of windage in various load conditions:
- Risks associated with excessive yaw;
- •Guidance on anchoring is vessel-specific and highlights that, when at anchor, the weight of the cable should be taken on the guillotine fittings, which should be correctly engaged.
